Toll Bridge Program Report

April 2022

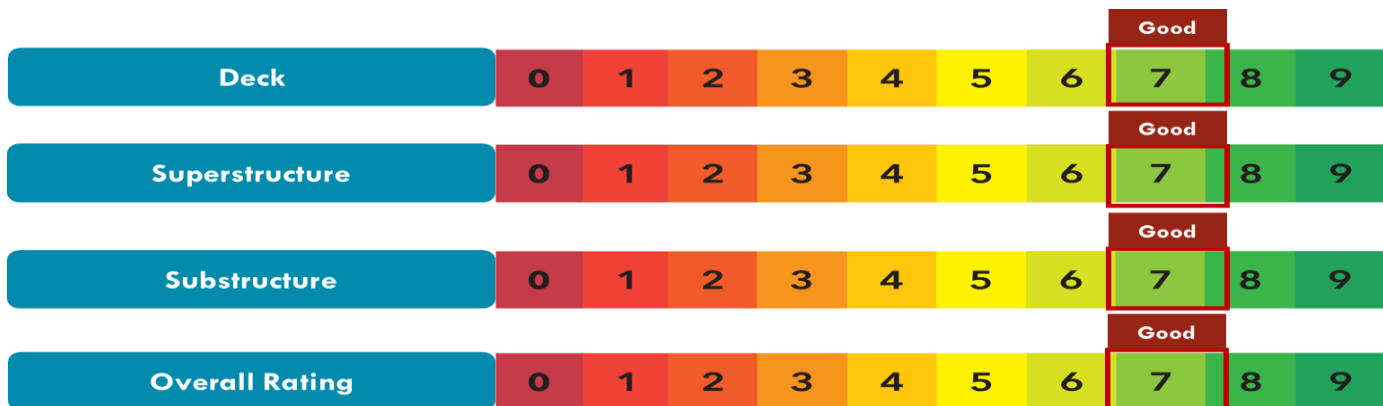
NBIS Structural Health Summary

The structural components of the Antioch bridge are in good overall condition. The bridge deck is in fair to good condition with signs of wear to the concrete surface. The bridge substructure is in good condition, with deterioration limited to surface cracks. The bridge's superstructure, constructed of weathering steel, is in

similarly good condition. Several elements of the bridge superstructure were replaced and an additional substructure bracing was added as part of the 2013 seismic retrofitting contract. While BATA continues funding the ongoing routine maintenance work on the bridge, the bridge does not have major rehabilitation projects planned through 2022-2027.

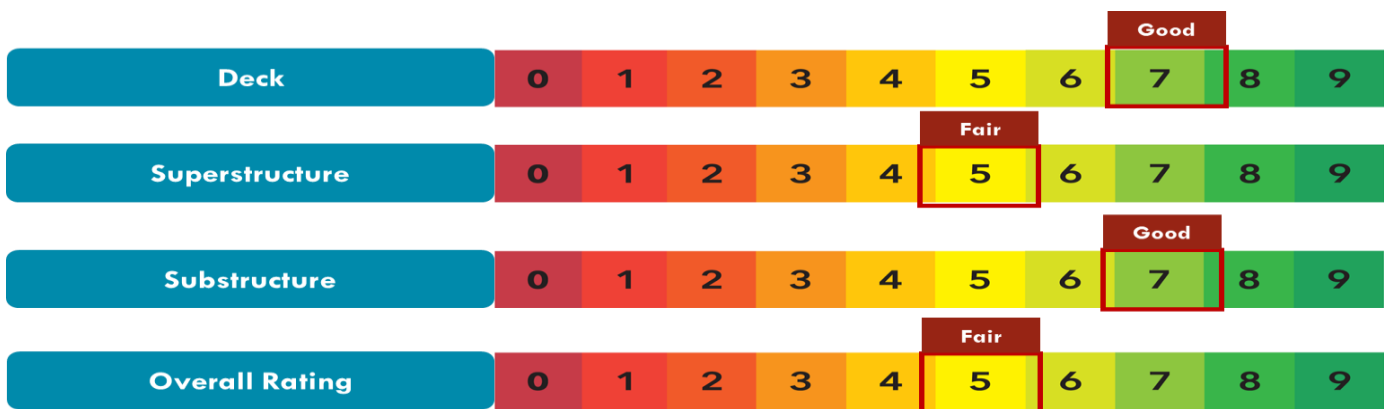
Southbound

The structural components of both the northbound and southbound Benicia-Martinez Bridge structures generally are in fair to good condition. The bridge deck is in good condition with signs of spalling and delamination which are being monitored and repaired as part of the ongoing routine maintenance work. The bridge’s substructure is in overall good condition with some shrinkage cracks in the bridge towers.

While the superstructure of the northbound bridge is in good condition, the southbound superstructure is in fair condition, with the deck truss along the floor beams showing signs of deterioration which is being monitored. While BATA continues funding the ongoing routine maintenance work on the bridge, the bridge does not have major rehabilitation projects planned through 2022-2027.

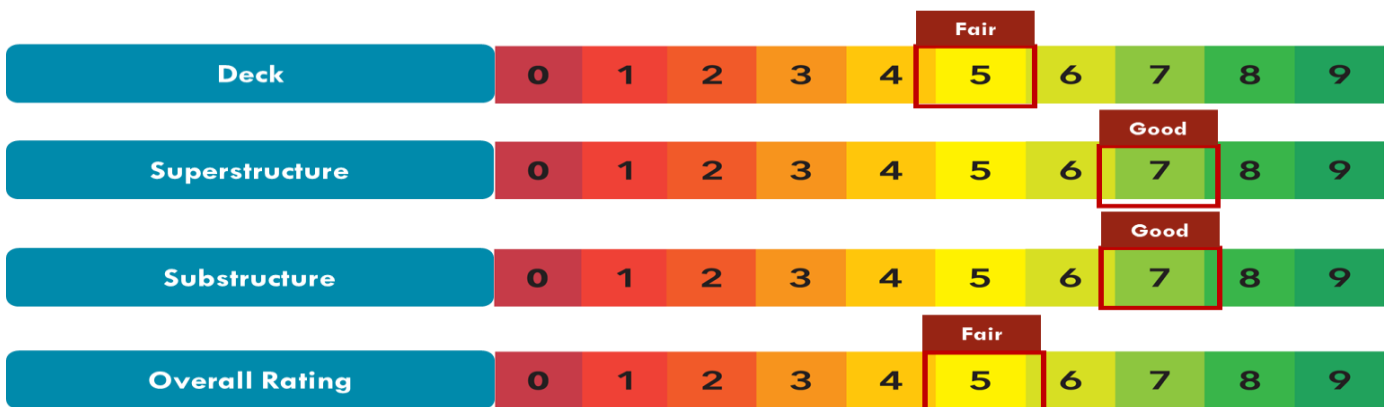
Eastbound

The structural components of the Carquinez Bridge generally are in fair to good condition. The eastbound bridge deck is in fair condition. A deck rehabilitation project to the eastbound approach structure (Contract 04-3G4034) was completed in 2016. The westbound bridge deck is in good condition, with signs of wear and rutting. While BATA continues funding the ongoing routine maintenance work on the bridge, the bridge does not have major rehabilitation projects planned through 2022-2027.

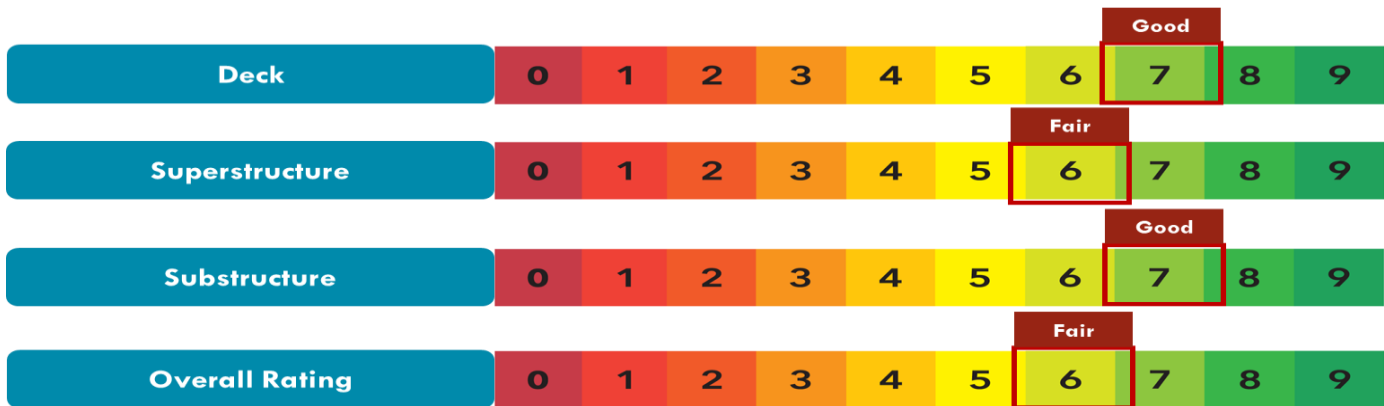
NBIS Structural Health Summary

The structural components of the Dumbarton Bridge generally are in fair to good condition. The bridge deck is in good condition, with small cracks. The bridge’s substructure is in good condition, with minor shrinkage cracks in the concrete surface. The superstructure elements also are in good condition, with signs of deterioration.

While BATA continues funding the ongoing routine maintenance work on the bridge, the bridge does not have major rehabilitation projects planned through 2022-2027.

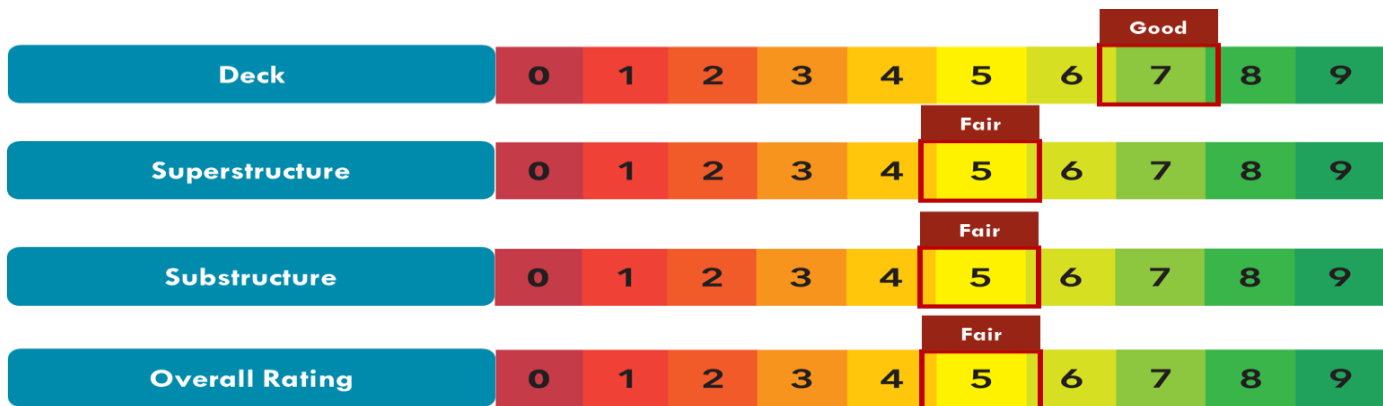
NBIS Structural Health Summary

The structural components of the Richmond-San Rafael Bridge are in overall fair to good condition. The bridge deck is in good condition with signs of delamination and spalls in the surface. The bridge’s substructure is in fair condition, with signs of deterioration. The superstructure is in fair condition, with the steel truss spans and the steel girder spans showing signs of deterioration. A number of bridge deck joints were replaced as part of the structural steel paint project. According to the 10-Year Toll Bridge Rehabilitation Capital Funding program, over \$100 million will be invested between 2022 and 2027 to fund maintenance and rehabilitation projects on the Richmond-San Rafael Bridge.

Project Description	Budget (Includes Support Cost and change orders)	2022	2023	2024	2025	2026	2027
Structural steel paint repair, removal of travelers and misc.	\$43 Million						
Gusset plate strengthening	\$20 Million

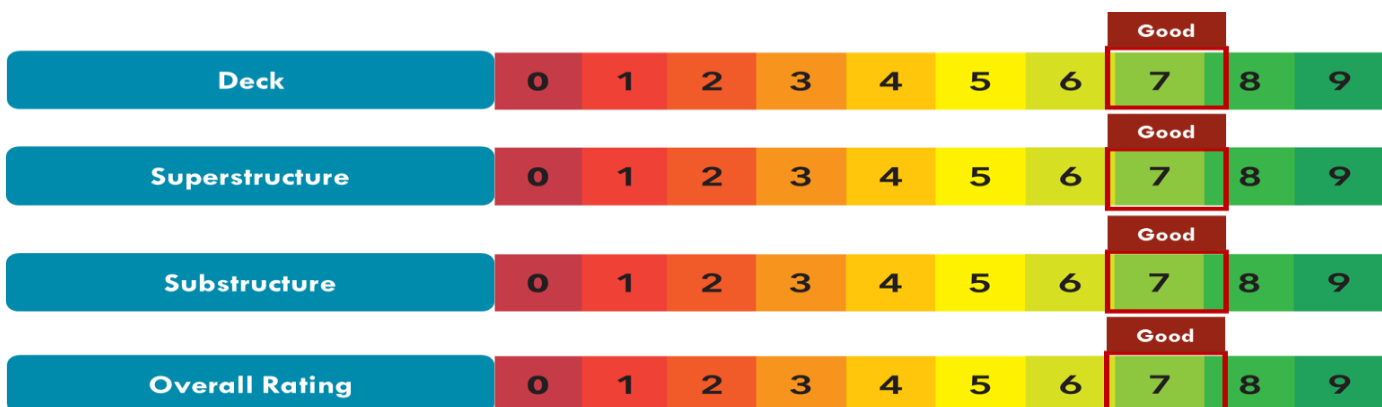
The East Span of the Bay Bridge is in good overall condition with slight signs of deterioration to its deck, structural components, and paint. No major rehabilitation projects are planned in the next 10 years. The older West Span, which is in fair condition, is the focal point for rehabilitation work. Current projects are dedicated to preventative maintenance. These include a major effort to paint the structural steel of the floor system and towers. As part of the 10-Year Toll Bridge Rehabilitation Capital Funding program, approximately \$400 million will be invested between 2022 and 2027 to fund maintenance and rehabilitation projects on the San Francisco-Oakland Bay Bridge.

Project Description	Budget (includes support cost)	2022	2023	2024	2025	2026	2027
Replace Seismic Dampers- West Span (WS)	\$32 Million	█					
Rehabilitate Fire Protection System at Yerba Buena Island (YBI) Tunnel	\$22 Million	█					
Interim Repair of The SFOBB West Span Fender System	\$9 Million	█

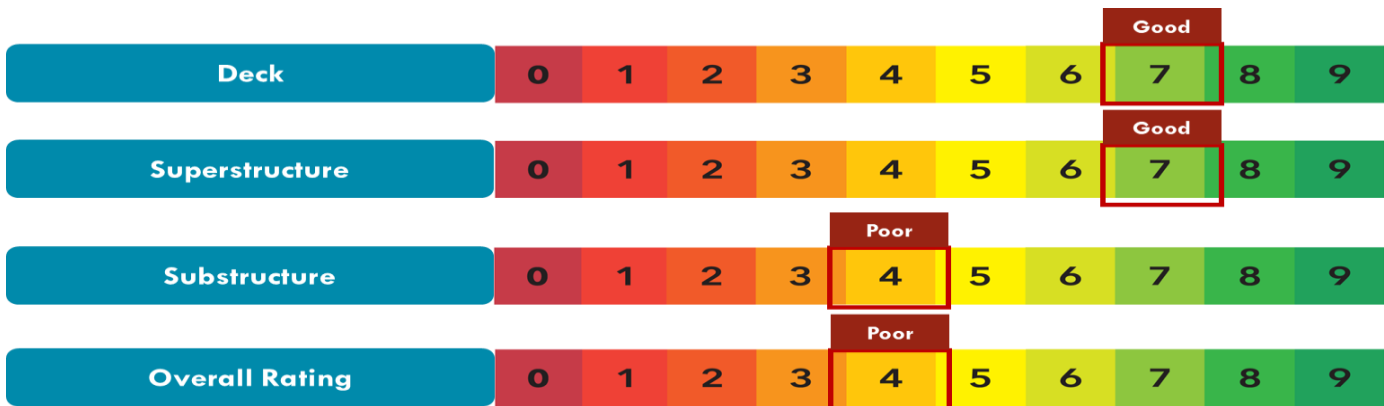
NBIS Structural Health Summary

While the superstructure and deck of the San Mateo-Hayward Bridge are rated as good on the NBIS scale, Caltrans identified in 2016 spalling concrete on the pile caps of the older 1967 low-rise trestle section that resulted in a poor substructure and overall bridge condition rating. The spalling is due to the age of the structure, exposure to the bay environment and normal wear and tear. The poor rating does not mean the bridge is unsafe for the traveling public. The design of the trestle provides redundancy in the structural system, and the identified conditions do not indicate a safety risk which necessitates a closure.

A \$36 million Phase 1 rehabilitation of the bridge piers began in March 2020 and is on-going. The substructure component rating of the bridge is anticipated to rise to fair after completion of the work. In addition to the ongoing concrete repair work, additional toll bridge rehabilitation and paint projects are programmed in the Toll Bridge Rehabilitation Program. The total investment in the maintenance and rehabilitation of the San Mateo Hayward Bridge will be over \$100 million between 2022 and 2027.
