Toll Bridge Program Report

January 2025

This is the 3rd Toll Bridge Program report which presents updates on the conditions of the San Francisco Bay Area's seven state-owned toll bridges. The Bay Area Toll Authority (BATA) and the California Department of Transportation (Caltrans) work together to continually monitor the toll bridges to preserve their integrity and reliability.

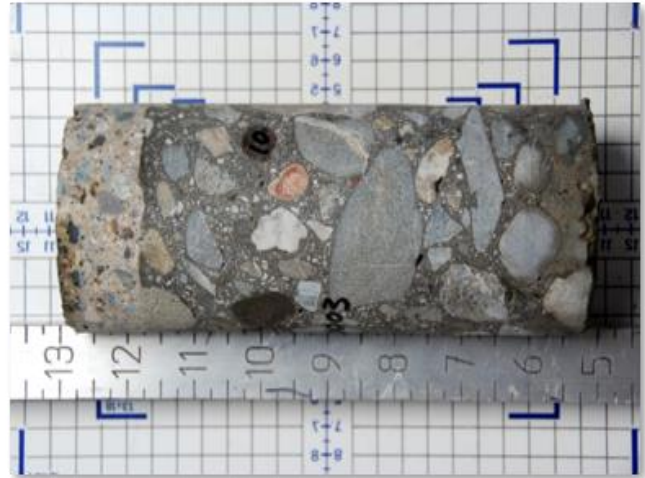
Figure 1-B: Core samples to evaluate concrete reinforcing steel

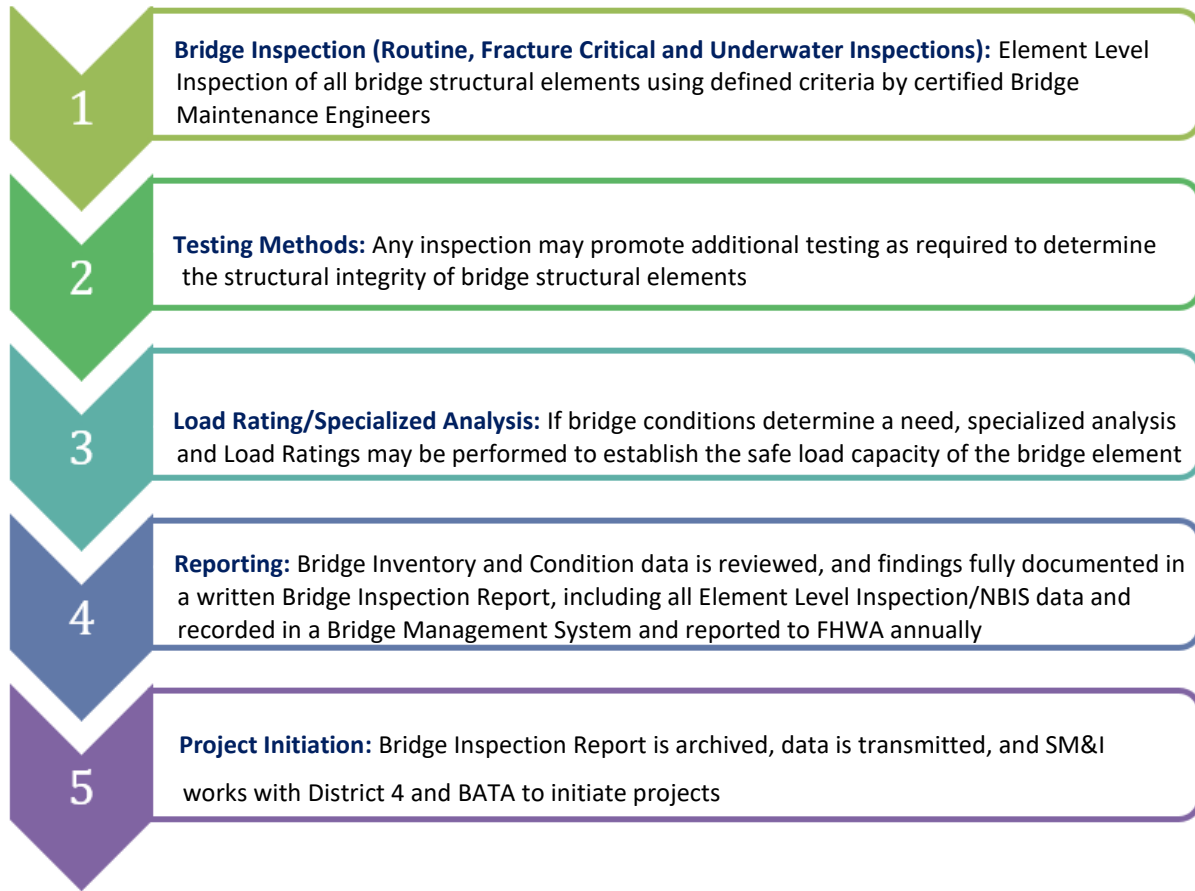
Figure 2 Bridge Management at Work: Inspection, Reporting, and Project Initiation

The result of every bridge inspection (whether routine or specialty) is documented in a formal Bridge Inspection Report that is signed and sealed (with an engineer’s stamp) and archived in the state-managed Bridge Inspection Report Information System (BIRIS) for historical purposes. Bridge inspection data is reported to the Federal Highway Administration annually in compliance with mandated inspection and reporting requirements. All data collected during the inspection process is documented and maintained in the Structural Maintenance Automated Report Transmittal (SMART) bridge management system. Maintaining quality data is considered the cornerstone to assuring the safety and integrity of these bridges. Based on the inspection data, the SM&I unit makes structure work repair recommendations, which in turn drive maintenance and rehabilitation projects. The SM&I unit also is responsible for delivering plans, specifications and estimates for bridge maintenance projects, and for determining the safe load capacity of all bridges. **Error! Reference source not found.** shows a schematic diagram that summarizes the bridge management process.

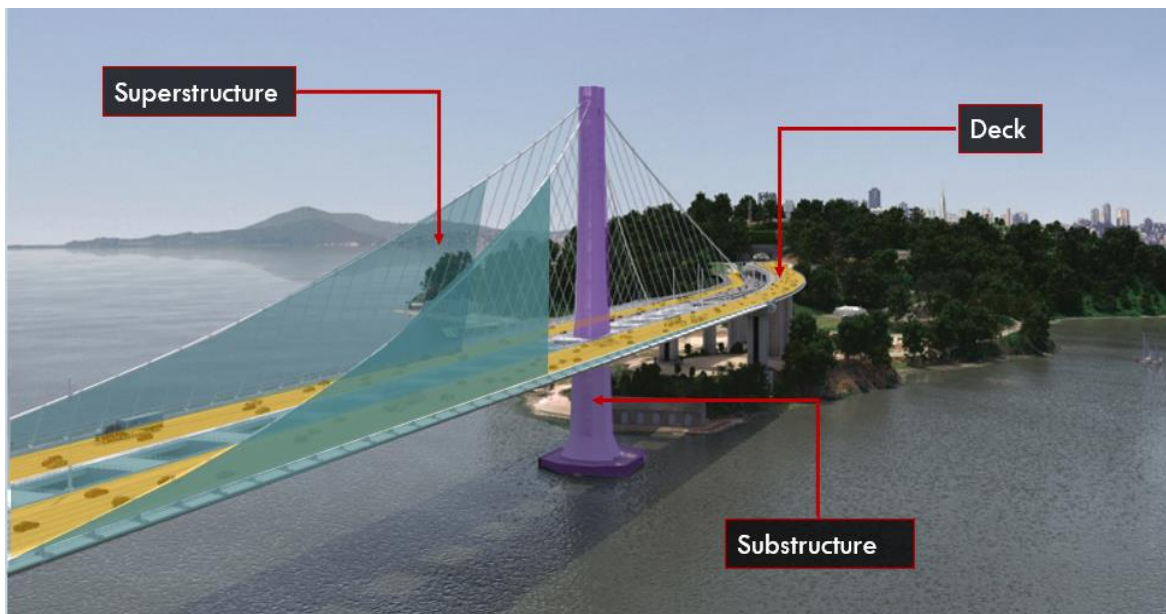
Figure 4 The Three Bridge Main Components

A graphical depiction of the three bridge components is shown in Figure 4. The bridge deck is the portion of the bridge that directly carries the traffic (i.e., road surface). The substructure is the portion of the bridge that supports the superstructure and transmits all the bridge loads to the ground. The superstructure is the portion of the bridge that supports the deck and connects the substructure parts together as it carries loads from the deck to the substructure. Caltrans performs element-level inspections on all three main bridge components, which provide additional detail on what portions of a bridge may be deteriorated. The results of the element-level inspections are used to derive the NBI deck, superstructure, and substructure ratings. The FHWA occasionally updates the SNBI to incorporate best practices and technological advancements. These updates can influence inspection processes and eventually the condition ratings. The 2022 SNBI update will be implemented in 2025 and be reflected in future reports.

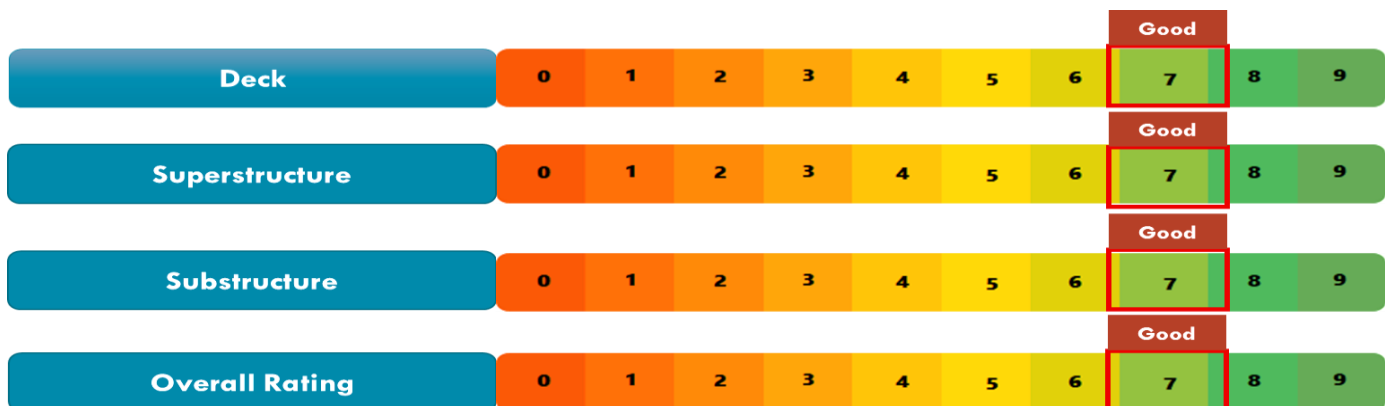
NBIS Structural Health Summary

The structural components of the Antioch bridge are in good overall condition. The bridge deck is in good condition with minor signs of typical wear to the concrete surface. The bridge substructure is in good condition,

with deterioration limited to surface cracks. The bridge’s superstructure, constructed of weathering steel, is in similarly good condition. Several elements of the bridge superstructure were replaced, and an additional substructure bracing was added as part of the 2013 seismic retrofitting contract. The fender system is in fair to good condition with various stages of deterioration. A fender rehabilitation project to address these issues is planned for FY 25/26. The following table summarizes the planned projects according to the updated FY24 BATA Capital Improvement Plan (CIP):

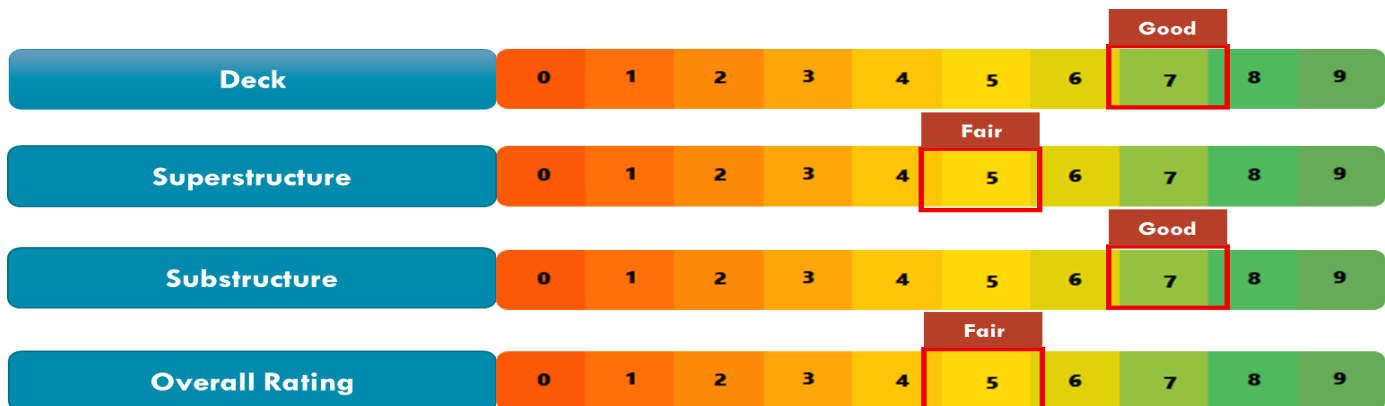
Southbound

The structural components of both the northbound and southbound Benicia-Martinez Bridge structures generally are in fair to good condition. The bridge deck, in the southbound direction, is in good condition with signs of spalling and delamination which are being monitored and repaired as part of the ongoing routine maintenance work. The bridge deck in the northbound direction is in good condition with minor signs of typical wear to the concrete surface. The bridge’s substructure is in overall good condition with some shrinkage cracks in the bridge towers.

While the superstructure of the northbound bridge is in good condition, the southbound superstructure is in fair condition, with the deck truss along the floor beams showing signs of deterioration which is being closely monitored. The fender system is in good condition for both bridge structures. The following table summarizes the planned projects according to the updated FY24 BATA Capital Improvement Plan (CIP):

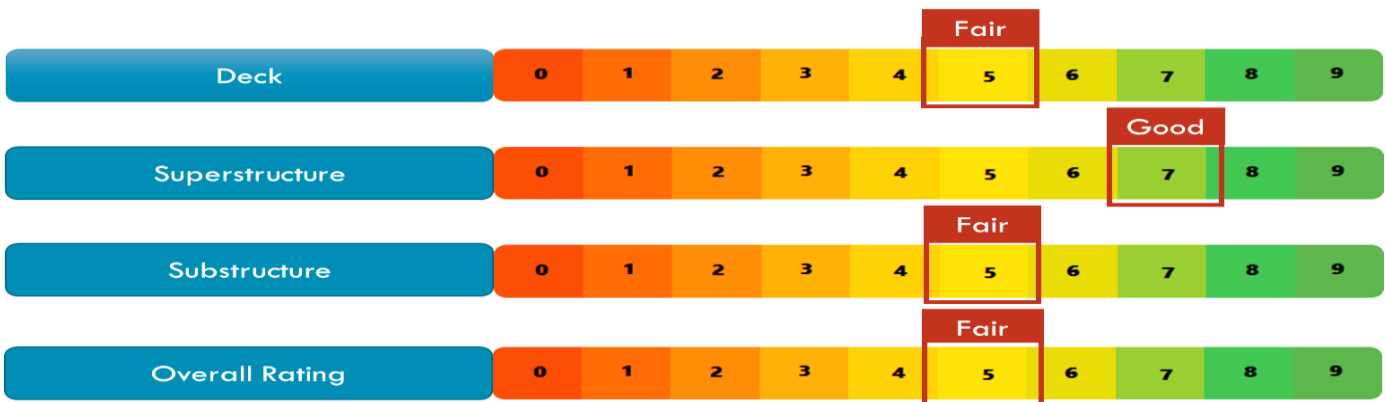
Eastbound

The structural components of the Carquinez Bridge generally are in fair to good condition. The eastbound bridge deck is in fair condition. A deck rehabilitation project to the eastbound approach structure (Contract 04-3G4034) was completed in 2016. The westbound bridge deck is in good condition, with signs of wear and rutting. The deck overlay is programmed for replacement in FY 24/25 (EA 04-1Y7704). The fender system is in good condition for both bridge structures. In the eastbound structure, the substructure condition rating changed from good to fair in the past two years due to an increased observation of corrosion. A painting project is scheduled for FY27/28 to address the deteriorating paint condition. The following table summarizes the planned projects according to the updated FY24 BATA Capital Improvement Plan (CIP):

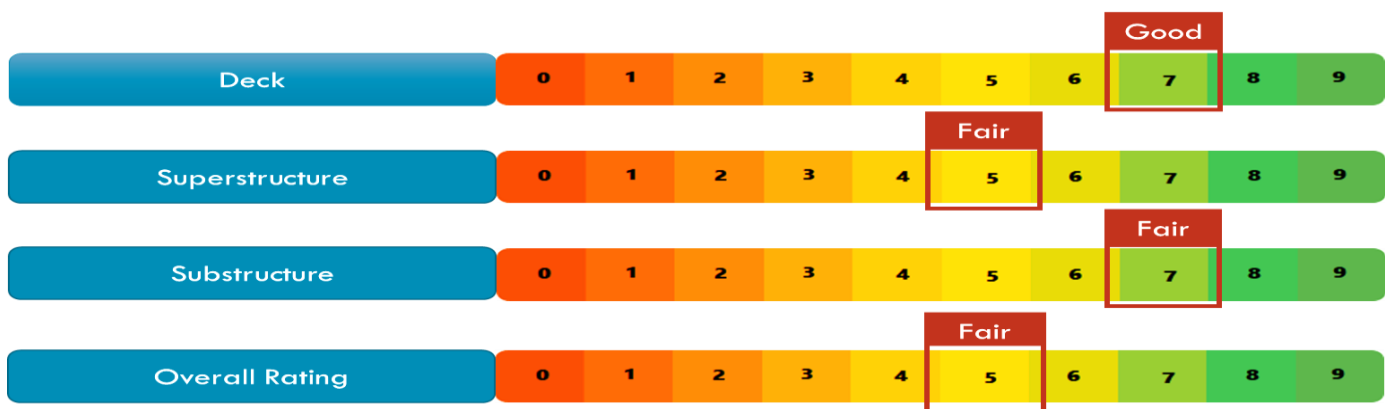
NBIS Structural Health Summary

The structural components of the Dumbarton Bridge generally are in fair to good condition. The bridge deck is in good condition, with small cracks. The bridge's substructure is in good condition, with minor shrinkage cracks in the concrete surface. The superstructure elements also are in fair condition, with some signs of deterioration.

The superstructure NBIS condition rating changed from 6 to 5 in the past two years due to an increased observation of corrosion on the external faces of the steel box girders. The fender system is in good condition with signs of minor deterioration. The following table summarizes the planned projects according to the updated FY24 BATA Capital Improvement Plan (CIP):

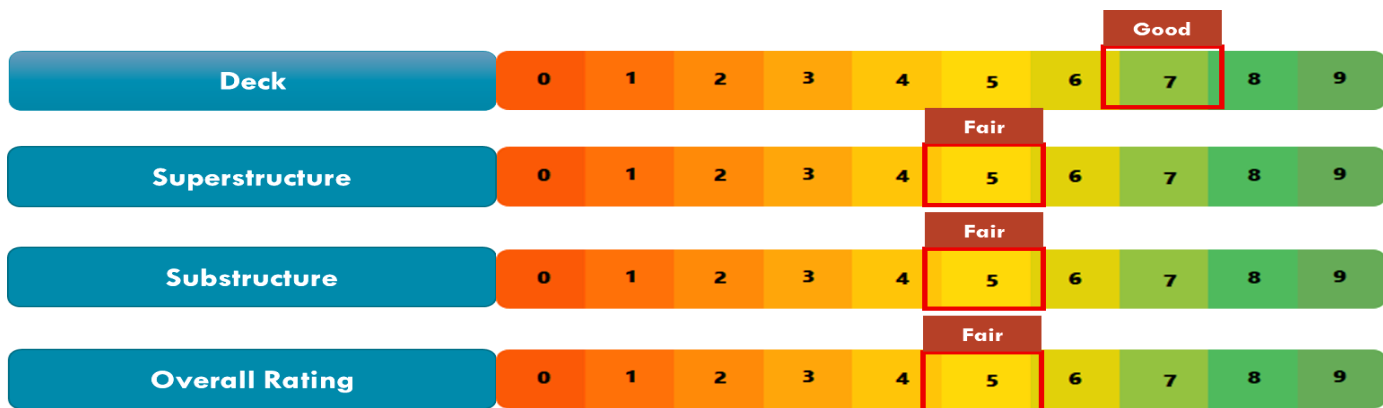
NBIS Structural Health Summary

The structural components of the Richmond-San Rafael Bridge are in overall fair to good condition. The bridge deck is in good condition with signs of delamination and spalls on the surface. The bridge's substructure is in fair condition, with signs of deterioration. The superstructure is in fair condition, with the steel truss spans and the steel girder spans showing signs of deterioration. A number of bridge deck joints were replaced as part of

the structural steel paint project. An additional joint seal replacement project is scheduled for FY25/26. Currently, around \$64 million has been invested as part of the revised BATA resolution 166 to repair the structural steel paint and repair the traveler systems as shown below. The following table summarizes the planned projects on Richmond San Rafael Bridge according to the updated FY24 BATA Capital Improvement Plan (CIP):

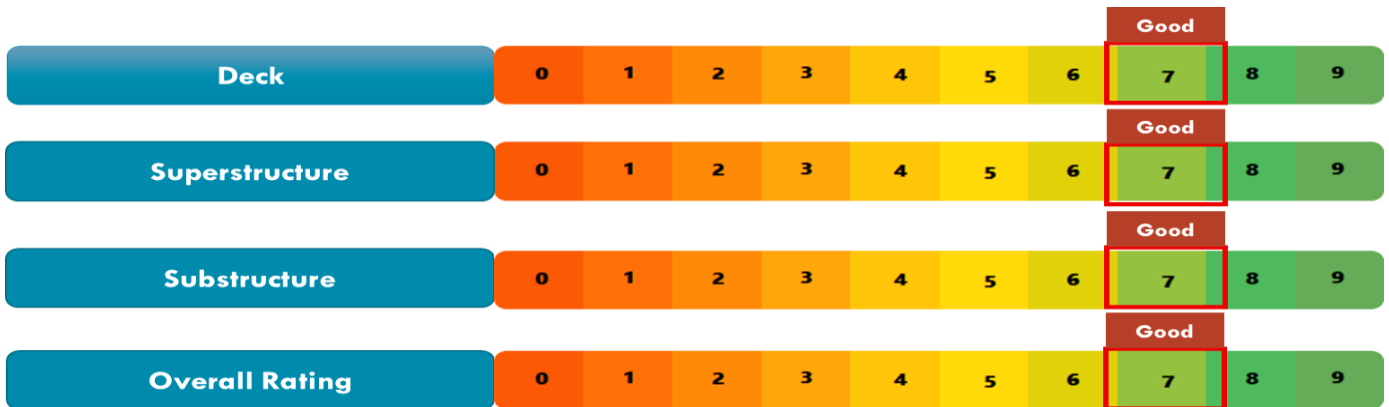
The East Span of the Bay Bridge is in good overall condition with slight signs of deterioration to its deck, structural components, and paint. No major rehabilitation projects are planned for the next 10 years. The older West Span, which is in fair condition, is the focal point for rehabilitation work. Current projects are dedicated to preventative maintenance. These include a major effort to paint the structural steel of the floor system in FY24/25. Recent updates to health regulations in California, which lowered the permissible exposure limit for lead in the workplace, may significantly impact the cost of this project. The cost estimates for this work will be closely monitored in 2025 when the new regulation takes effect and, the budget and CIP may be updated to reflect the actual costs. The following table summarizes the planned projects on the San Francisco Oakland Bay Bridge according to the updated FY24 BATA Capital Improvement Plan (CIP):

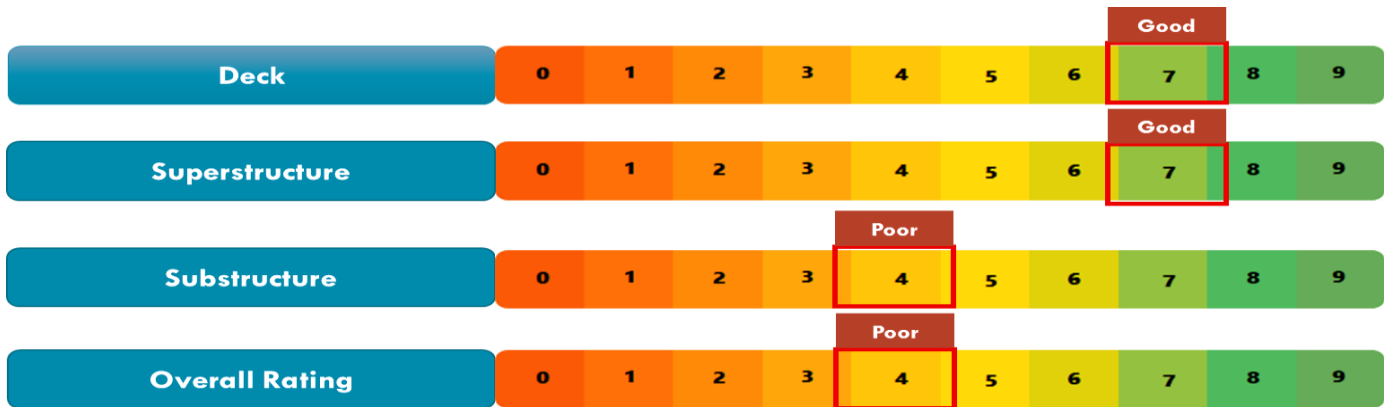
NBIS Structural Health Summary

While the superstructure and deck of the San Mateo-Hayward Bridge are rated as good on the NBIS scale, Caltrans identified, in 2016, spalling concrete on the pile caps of the older 1967 low-rise trestle section that resulted in a poor substructure and overall bridge condition rating. The spalling is due to the age of the structure, exposure to the bay environment and normal wear and tear. The poor rating does not mean the bridge is unsafe for the traveling public. The design of the trestle provides redundancy in the structural system, and the identified conditions do not indicate a safety risk. A \$45 million Phase 1 construction contract rehabilitation project to repair the bridge piers began in March 2020 and is expected to be completed in early 2025. Additionally, Caltrans is currently planning a Phase 2 rehabilitation project with an estimated budget of over \$118 million that will be available for bidding in 2025. Upon the completion of this work, the substructure component rating of the bridge is expected to improve to fair. In addition to the ongoing concrete repair work, additional toll bridge rehabilitation and paint projects are programmed in the Toll Bridge Capital Improvement Program (CIP). The following tables summarizes the planned projects on the San Mateo Hayward Bridge according to the updated FY24 BATA Capital Improvement Plan (CIP):
