Toll Bridge Program Report

January 2025

This is the 3rd Toll Bridge Program report which presents updates on the conditions of the San Francisco Bay Area's seven state-owned toll bridges. The Bay Area Toll Authority (BATA) and the California Department of Transportation (Caltrans) work together to continually monitor the toll bridges to preserve their integrity and reliability.

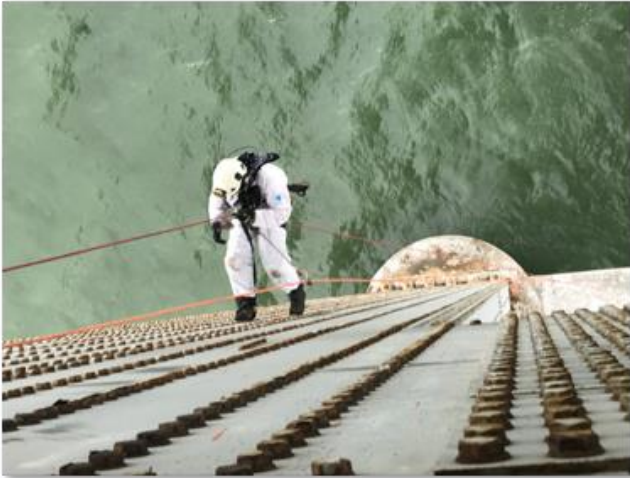
Figure 1-A: Rope access technique to assess details of paint

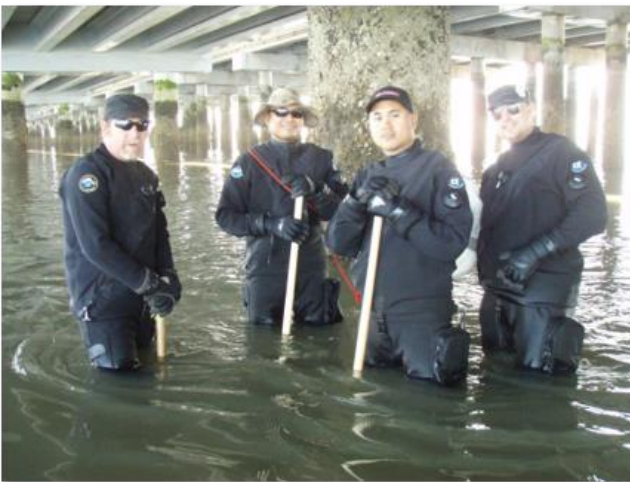
Figure 1-C: Bridge underwater inspection

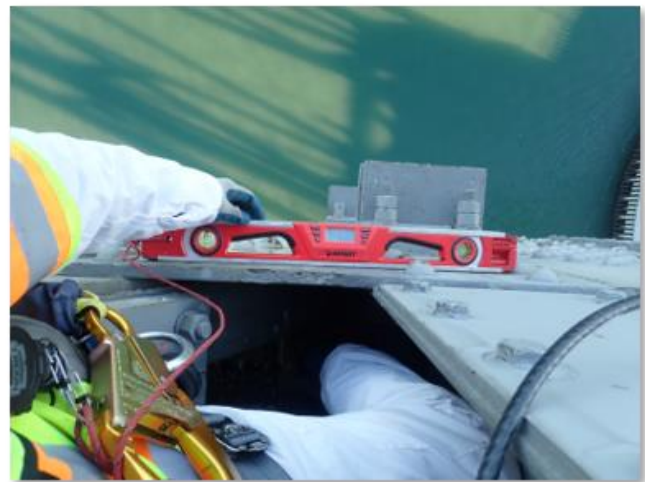
Figure 1-D: Physically measuring flatness

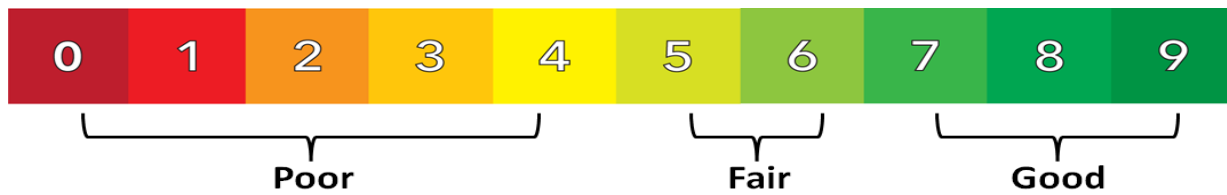
Figure 3 NBI Ratings for Bridge Conditions

Bridge condition ratings are used to classify a bridge as being in good, fair, or poor condition. The lowest of the three ratings for deck, superstructure, and substructure determines the overall rating of the bridge. If this value is seven or greater, the bridge has minimal wear to minor problems and is classified as being in good condition. If it is five or six, the bridge is classified as being in fair condition and the bridge may show signs of minor deterioration. If the rating is four or less, the bridge is classified as being in poor condition, which indicates that the bridge has advanced deficiencies and may require an accelerated repair or potential immediate action to fix the issue. It is important to note that the FHWA bridge condition rating is not a safety rating, but a tool to help record and track deterioration and prioritize projects and funding. Safety determinations are made by Caltrans

maintenance personnel who continuously monitor the bridges. Any structural safety deficiency is addressed at time of discovery. The NBI rating scale and the associated condition states are shown in Figure 3.

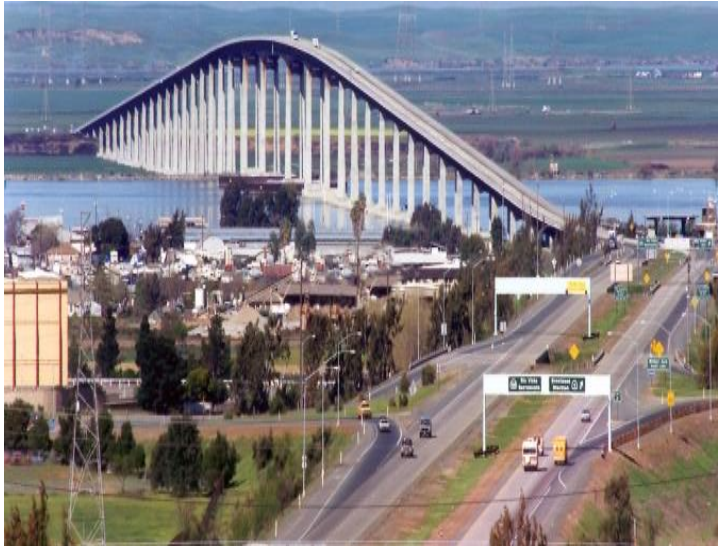
The Antioch Bridge spans the San Joaquin River, connecting northeastern Contra Costa County with Sacramento County. The 1.8-mile bridge features a concrete deck atop a steel plate girder system and opened to traffic in 1978. After Caltrans and the Bay Area Toll Authority evaluated the seismic safety of the Antioch Bridge, a 2013 seismic retrofit project was completed to make the bridge safer during a major earthquake.

The structural components of the Antioch bridge are in good overall condition. The bridge deck is in good condition with minor signs of typical wear to the concrete surface. The bridge substructure is in good condition,

with deterioration limited to surface cracks. The bridge’s superstructure, constructed of weathering steel, is in similarly good condition. Several elements of the bridge superstructure were replaced, and an additional substructure bracing was added as part of the 2013 seismic retrofitting contract. The fender system is in fair to good condition with various stages of deterioration. A fender rehabilitation project to address these issues is planned for FY 25/26. The following table summarizes the planned projects according to the updated FY24 BATA Capital Improvement Plan (CIP):

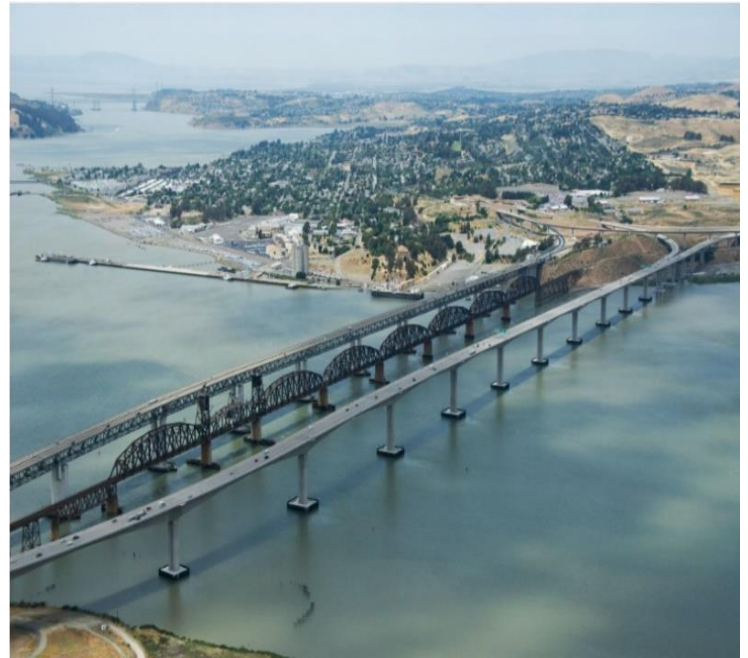
The Benicia-Martinez Bridge traverses the Carquinez Strait, carrying Interstate 680 between Solano and Contra Costa Counties. The 1.2-mile-long deck on steel truss structure was built in 1962, widened in 1991 and converted to southbound only traffic in 2009. In 2007, a second span was constructed adjacent to the original bridge to carry northbound only traffic.

The structural components of both the northbound and southbound Benicia-Martinez Bridge structures generally are in fair to good condition. The bridge deck, in the southbound direction, is in good condition with signs of spalling and delamination which are being monitored and repaired as part of the ongoing routine maintenance work. The bridge deck in the northbound direction is in good condition with minor signs of typical wear to the concrete surface. The bridge’s substructure is in overall good condition with some shrinkage cracks in the bridge towers.

While the superstructure of the northbound bridge is in good condition, the southbound superstructure is in fair condition, with the deck truss along the floor beams showing signs of deterioration which is being closely monitored. The fender system is in good condition for both bridge structures. The following table summarizes the planned projects according to the updated FY24 BATA Capital Improvement Plan (CIP):

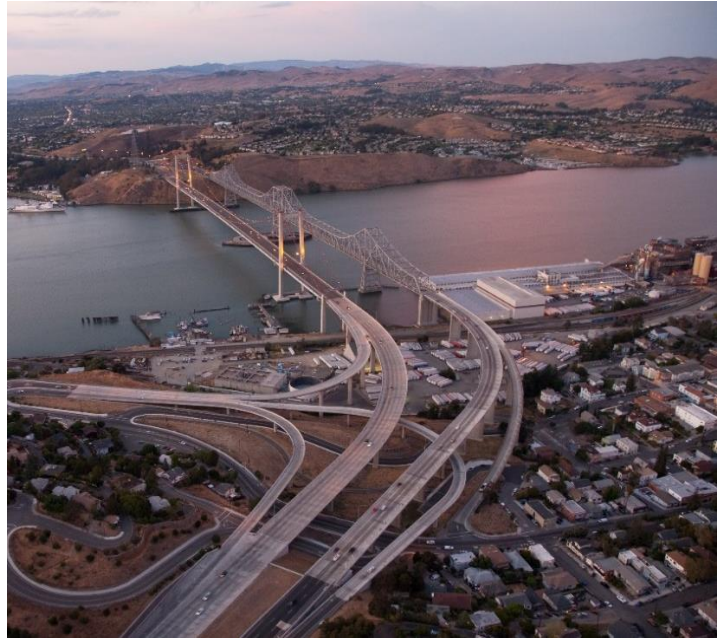
The Carquinez Bridge is a two-bridge system, measuring 0.7 and 0.8 miles long, respectively that carries Interstate 80 between Contra Costa and Solano counties, the original crossing opened in 1927. Due to the increase in traffic flow, Caltrans opened a parallel steel cantilever truss bridge for eastbound traffic in 1958. The 1927 original westbound span was replaced in 2003 with a cable suspension span for westbound traffic as part of the seismic retrofit program.

The structural components of the Carquinez Bridge generally are in fair to good condition. The eastbound bridge deck is in fair condition. A deck rehabilitation project to the eastbound approach structure (Contract 04-3G4034) was completed in 2016. The westbound bridge deck is in good condition, with signs of wear and rutting. The deck overlay is programmed for replacement in FY 24/25 (EA 04-1Y7704). The fender system is in good condition for both bridge structures. In the eastbound structure, the substructure condition rating changed from good to fair in the past two years due to an increased observation of corrosion. A painting project is scheduled for FY27/28 to address the deteriorating paint condition. The following table summarizes the planned projects according to the updated FY24 BATA Capital Improvement Plan (CIP):

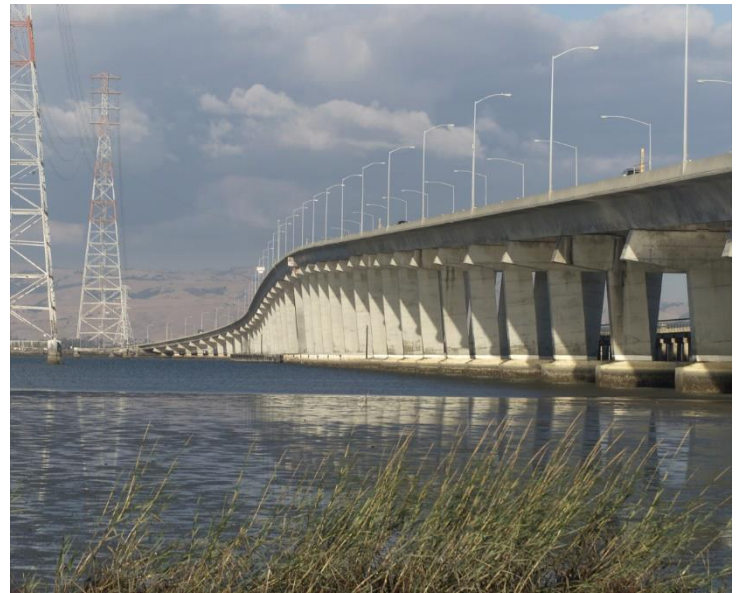
The Dumbarton Bridge carries State Route 84 for 1.6 miles between San Mateo and Alameda counties, with an eastern touchdown near Newark in Alameda County and a western landing near East Palo Alto in San Mateo County. The steel box girder main span and pre-stressed concrete approach spans were seismically retrofitted in 2013 to make the bridge safer during a major earthquake.

The structural components of the Dumbarton Bridge generally are in fair to good condition. The bridge deck is in good condition, with small cracks. The bridge's substructure is in good condition, with minor shrinkage cracks in the concrete surface. The superstructure elements also are in fair condition, with some signs of deterioration.

The superstructure NBIS condition rating changed from 6 to 5 in the past two years due to an increased observation of corrosion on the external faces of the steel box girders. The fender system is in good condition with signs of minor deterioration. The following table summarizes the planned projects according to the updated FY24 BATA Capital Improvement Plan (CIP):

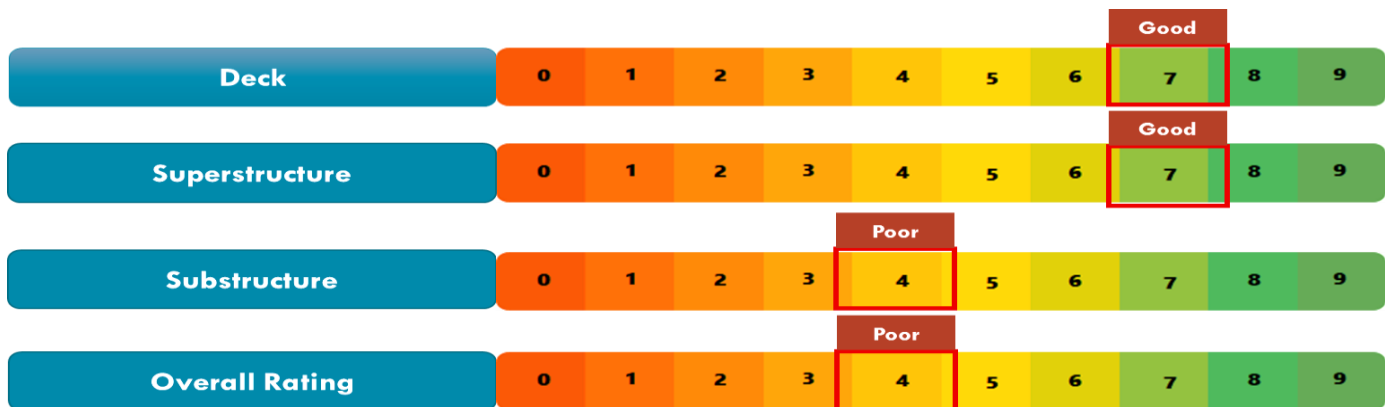
NBIS Structural Health Summary

While the superstructure and deck of the San Mateo-Hayward Bridge are rated as good on the NBIS scale, Caltrans identified, in 2016, spalling concrete on the pile caps of the older 1967 low-rise trestle section that resulted in a poor substructure and overall bridge condition rating. The spalling is due to the age of the structure, exposure to the bay environment and normal wear and tear. The poor rating does not mean the bridge is unsafe for the traveling public. The design of the trestle provides redundancy in the structural system, and the identified conditions do not indicate a safety risk. A \$45 million Phase 1 construction contract rehabilitation project to repair the bridge piers began in March 2020 and is expected to be completed in early 2025. Additionally, Caltrans is currently planning a Phase 2 rehabilitation project with an estimated budget of over \$118 million that will be available for bidding in 2025. Upon the completion of this work, the substructure component rating of the bridge is expected to improve to fair. In addition to the ongoing concrete repair work, additional toll bridge rehabilitation and paint projects are programmed in the Toll Bridge Capital Improvement Program (CIP). The following tables summarizes the planned projects on the San Mateo Hayward Bridge according to the updated FY24 BATA Capital Improvement Plan (CIP):

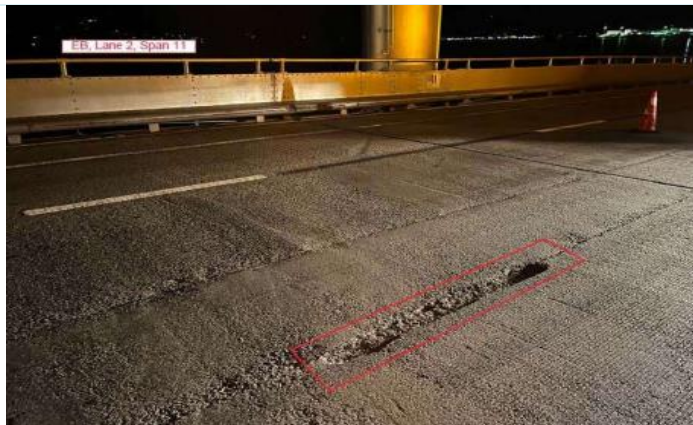
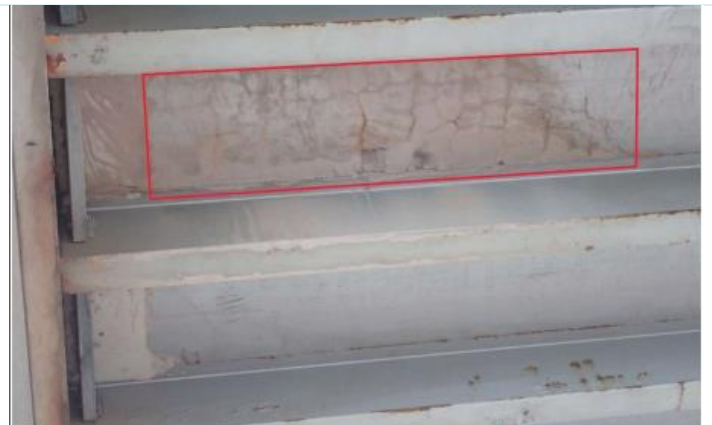
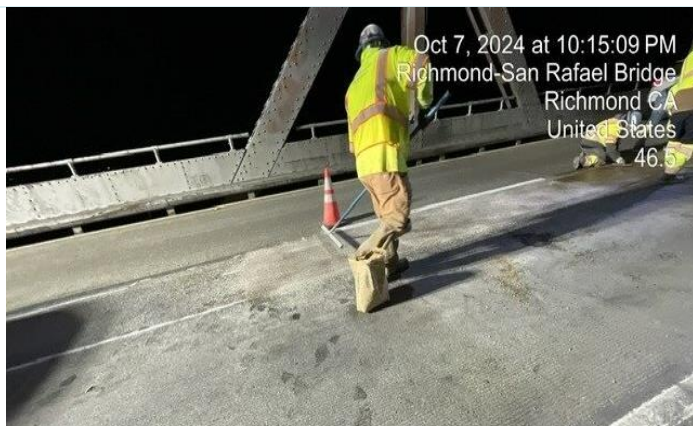
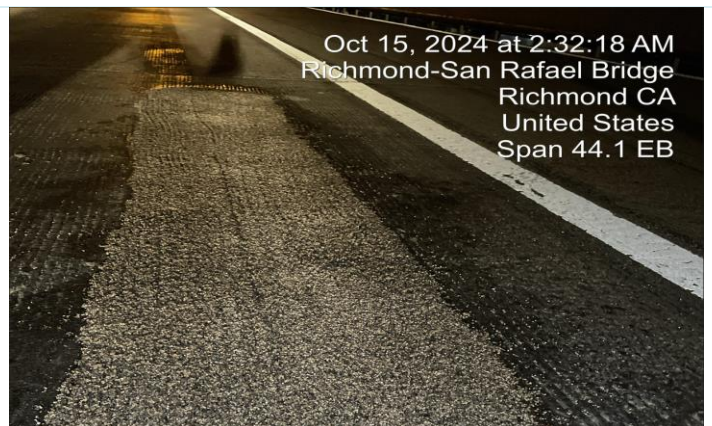
Contract No. 04-1X720: Repair Bridge Deck Section

This contract will remove cracked and unsound concrete, replace compromised reinforcement as necessary at various deck sections and replace it with polyester concrete.

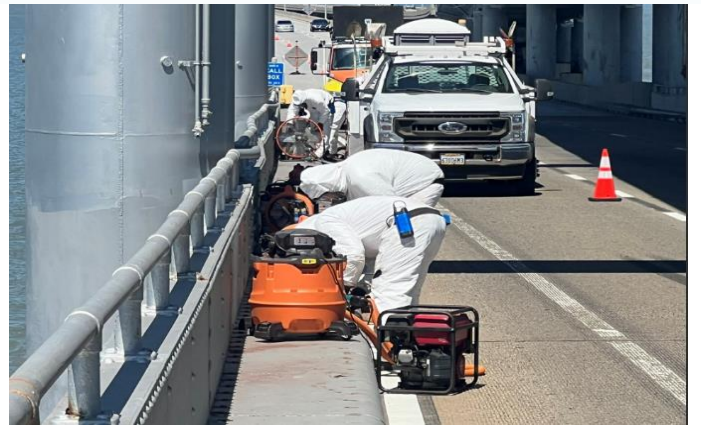
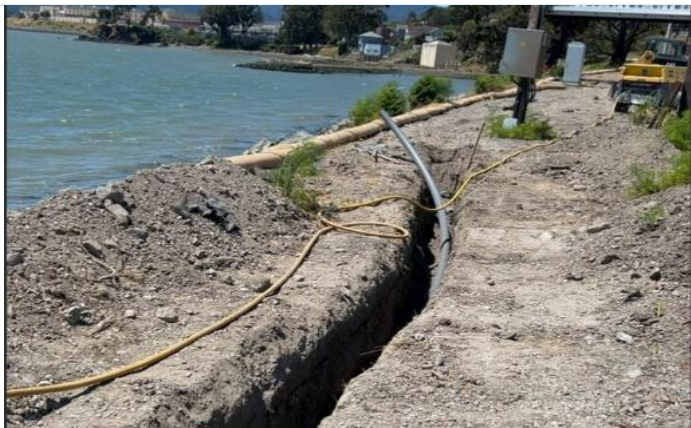
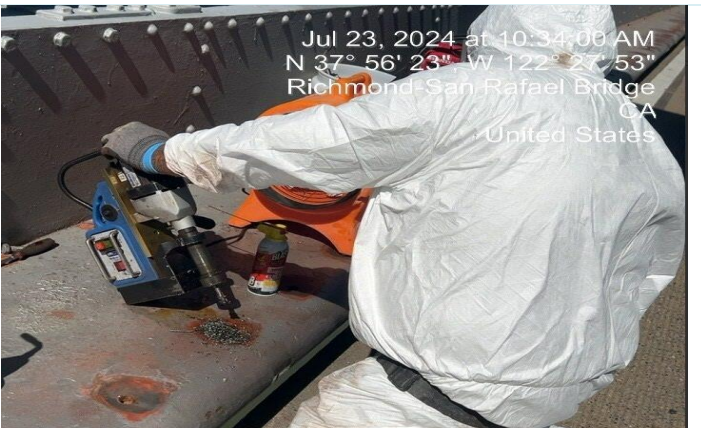
Contract No. 04-3G364: Upgrade Electrical Substations and Power Cables

This project will upgrade the 4 existing electrical substations, upgrade the existing 5kV power supply to 12kV, and replace existing main communication cables feeding the substations.

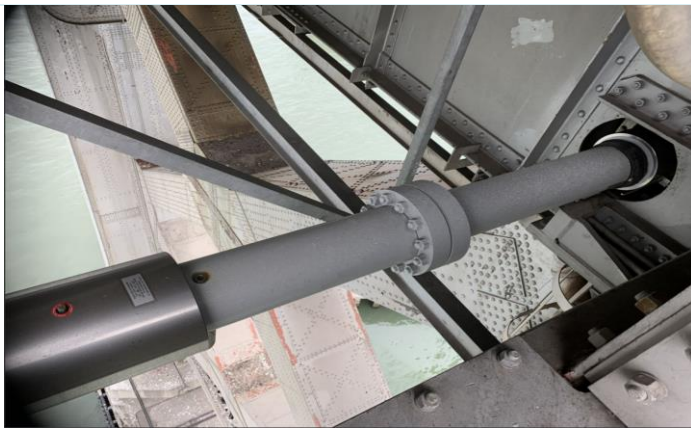
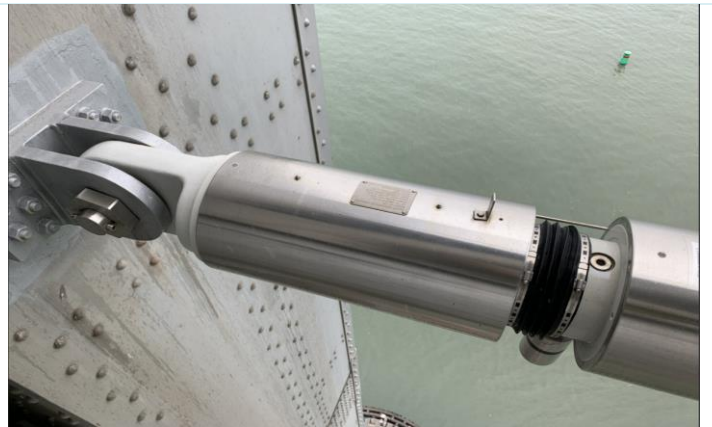
Contract No. 04-3G4424: Replace Seismic Dampers – West Span (WS)

This project will replace the seismic dampers on the West Span of the San Francisco-Oakland Bay Bridge with new dampers. Additional strengthening of the West Span steel structure is also being performed.

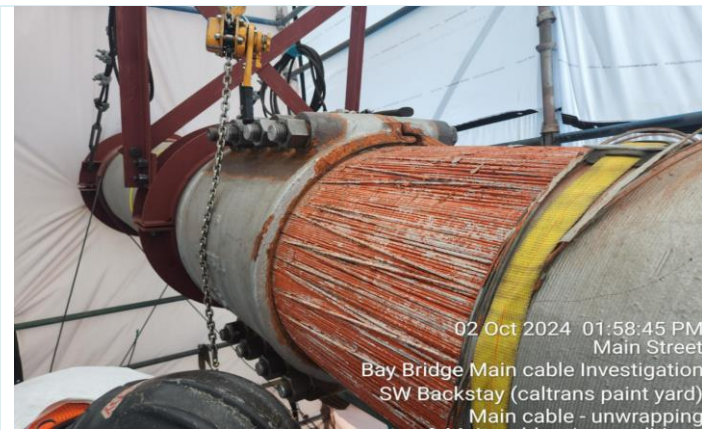
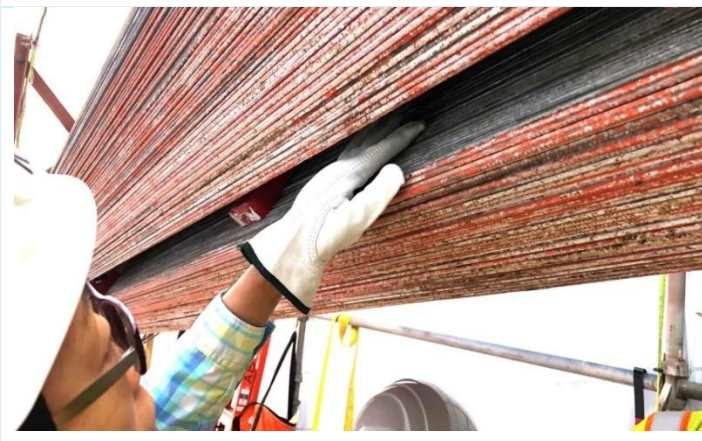
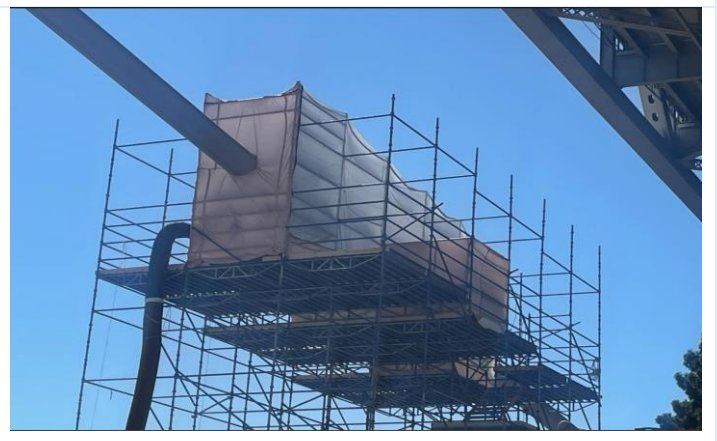
Contract No. 04-3G444: Main Cable Investigation and Suspender Rope Replacement

This project is to systematically inspect the main cable of the west span of the San Francisco Oakland Bay Bridge. The main cable will be opened at 10 different locations along the west span and lab testing will be performed on a representative sample of the cable wires. The main goal of this project is to identify any issues that may impact the safe and the reliable performance of the bridge.

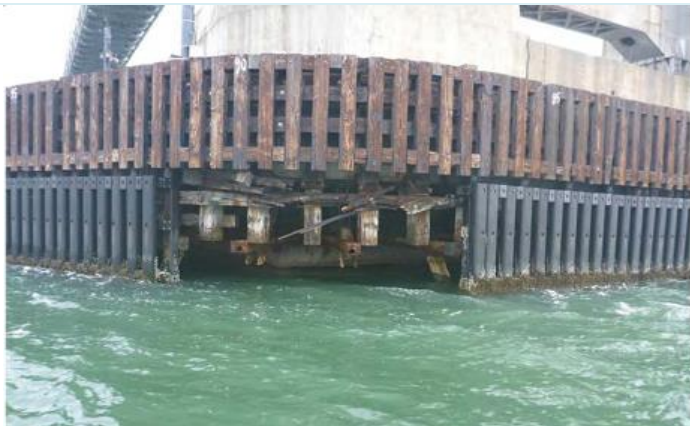
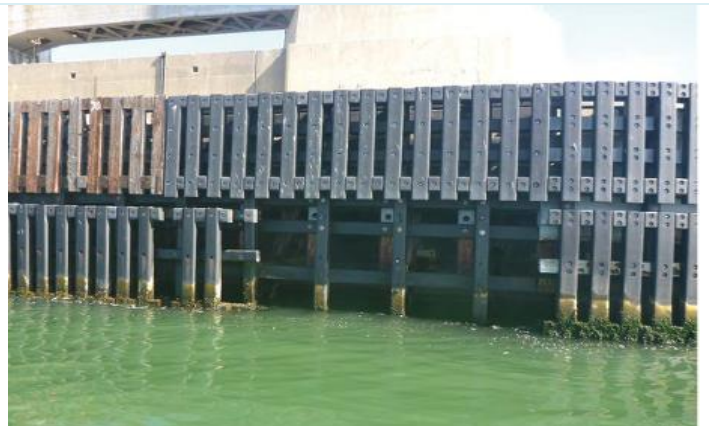
Contract No. 04-4W0104: Interim repair of the SFOBB West Span fender system

This project will perform interim repairs the fender system of the San Francisco-Oakland Bay Bridge’s West Span; at Piers W3, W4, W5, and W6 from Yerba Buena Island to the touchdown in San Francisco. This work includes temporary reinforcing the system’s functionality by removing damaged portions of the existing fender system and sheathing and installing plastic lumber posts anchored to the innermost existing upper posts.

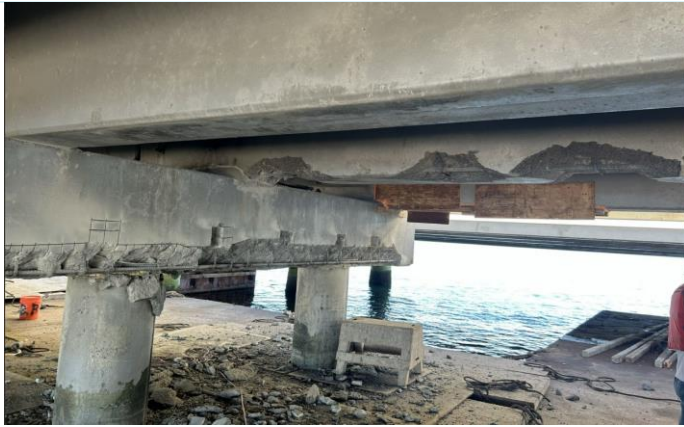
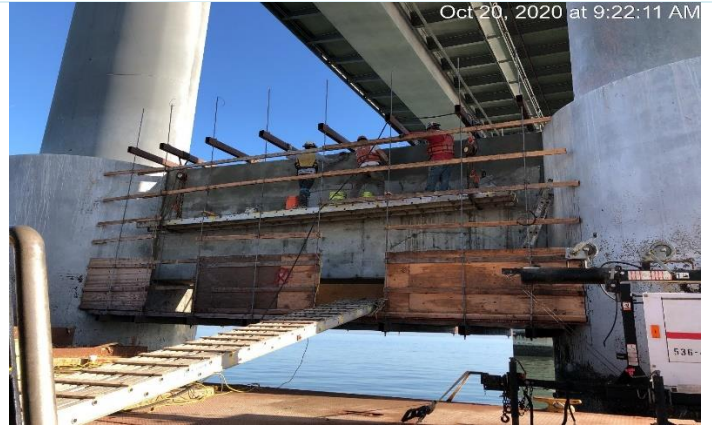
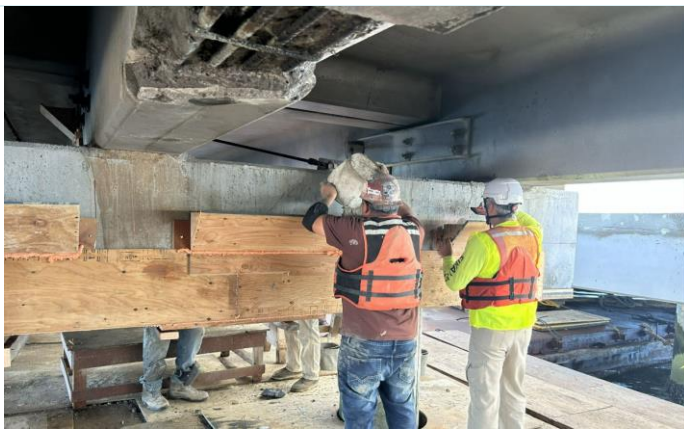
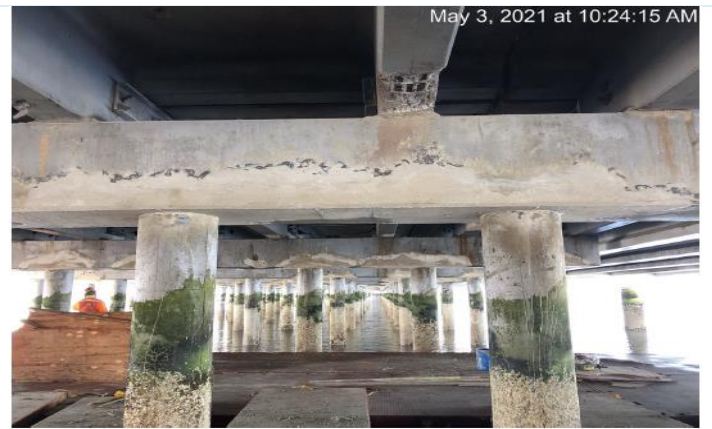
Contract No. 04-3G4544: Spandrel Beam Reconstruction and Pier Cap Repair-Phase 1

Spandrel beam and pier cap structural repairs on the high-rise section of the bridge from Piers 12 to 29 (excluding piers 19 and 20), and pier cap and girder repairs on Trestle Section from Piers 286 to the east abutment.
