# **Toll Bridge Program Report**

November 2025

# Introduction

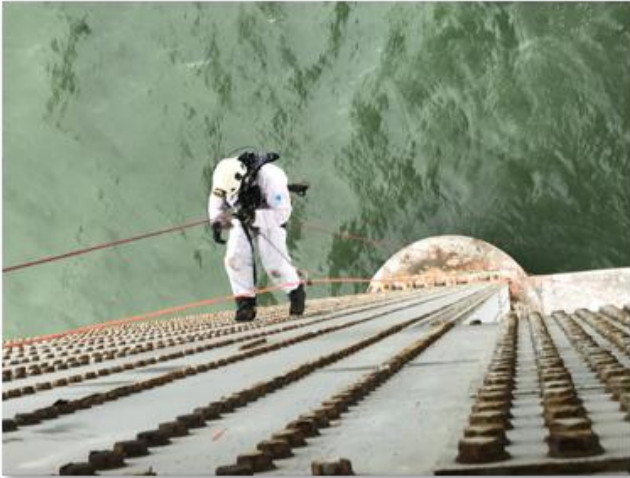
*Figure 1-A: Rope access technique to assess details of paint*

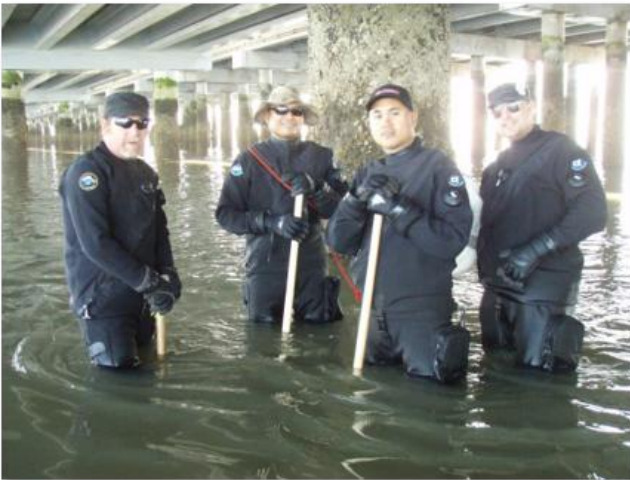
*Figure 1-C: Bridge underwater inspection*

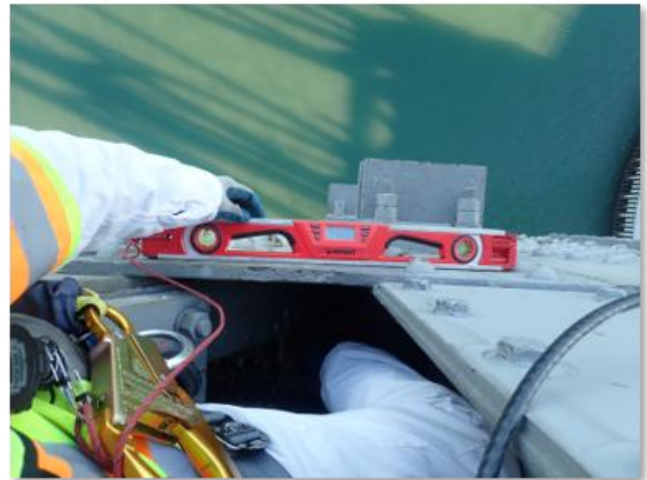
*Figure 1-D: Physically measuring flatness*

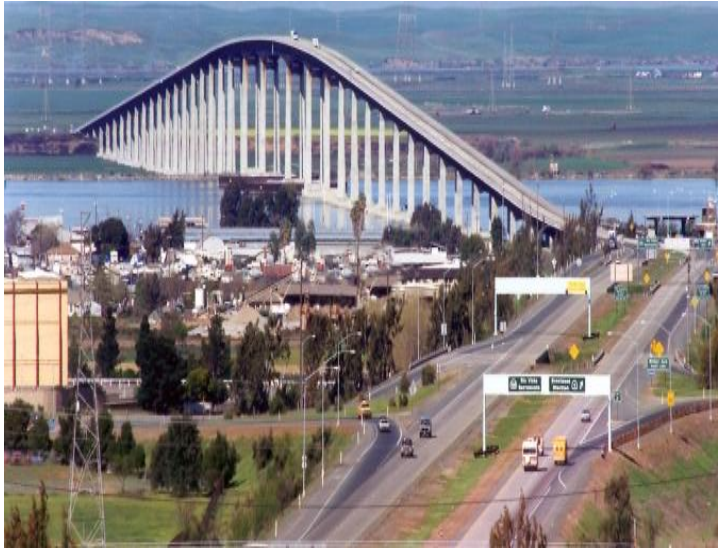
The Antioch Bridge spans the San Joaquin River, connecting northeastern Contra Costa County with Sacramento County. The 1.8-mile bridge features a concrete deck atop a steel plate girder system and opened to traffic in 1978. After Caltrans and the Bay Area Toll Authority evaluated the seismic safety of the Antioch Bridge, a 2013 seismic retrofit project was completed to make the bridge safer during a major earthquake.

The structural components of the Antioch bridge are in good overall condition. The bridge deck is in good condition with minor signs of typical wear to the concrete surface. The deck surface was treated in 2002 with

methacrylate to seal the cracks. A deck rehabilitation project consisting of a polyester concrete overlay is currently programmed for FY 2033-34. The bridge substructure is in good condition, with deterioration limited to surface cracks. The bridge's superstructure, constructed of weathering steel, is in similarly good condition. Several elements of the bridge superstructure were replaced, and an additional substructure bracing was added as part of the 2013 seismic retrofitting contract. The main bridge is constructed out of weathering steel, which does not require any paint. The only elements that will need to be painted are the steel tower braces that were placed as part of the 2012 seismic retrofit. The fender system is in fair to good condition with various stages of deterioration. A fender rehabilitation project to address these issues is planned for FY 2027-28. The following table summarizes the planned projects according to the updated BATA 10-Year Toll Bridge Capital Improvement Plan (CIP) for FY 2024-33:

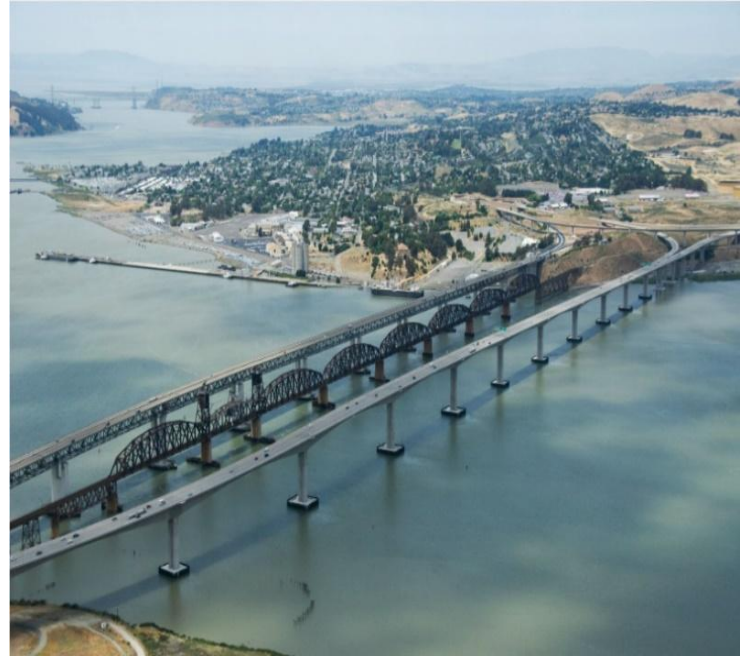
The Benicia-Martinez Bridge traverses the Carquinez Strait, carrying Interstate 680 between Solano and Contra Costa Counties. The 1.2-mile-long deck on steel truss structure was built in 1962, widened in 1991 and converted to southbound only traffic in 2009. In 2007, a second span was constructed adjacent to the original bridge to carry northbound only traffic.

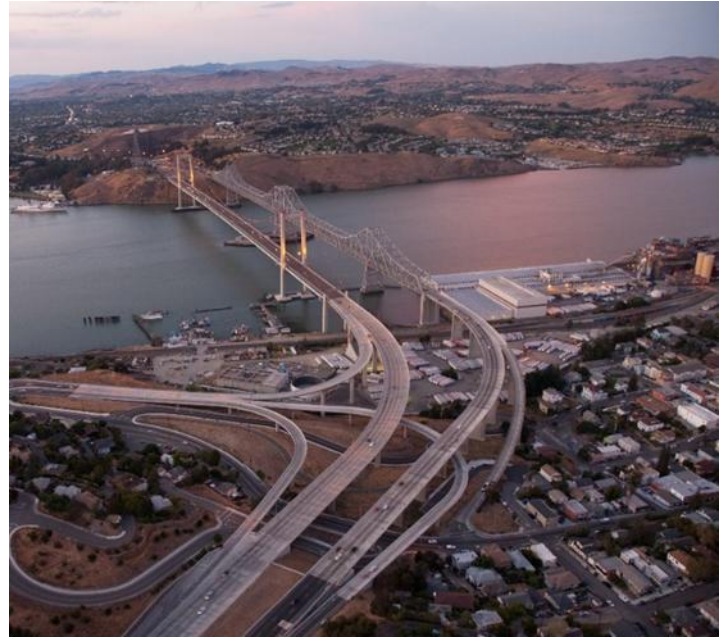
The Carquinez Bridge is a two-bridge system, measuring 0.7 and 0.8 miles long, respectively that carries Interstate 80 between Contra Costa and Solano counties, the original crossing opened in 1927. Due to the increase in traffic flow, Caltrans opened a parallel steel cantilever truss bridge for eastbound traffic in 1958. The 1927 original westbound span was replaced in 2003 with a cable suspension span for westbound traffic as part of the seismic retrofit program.

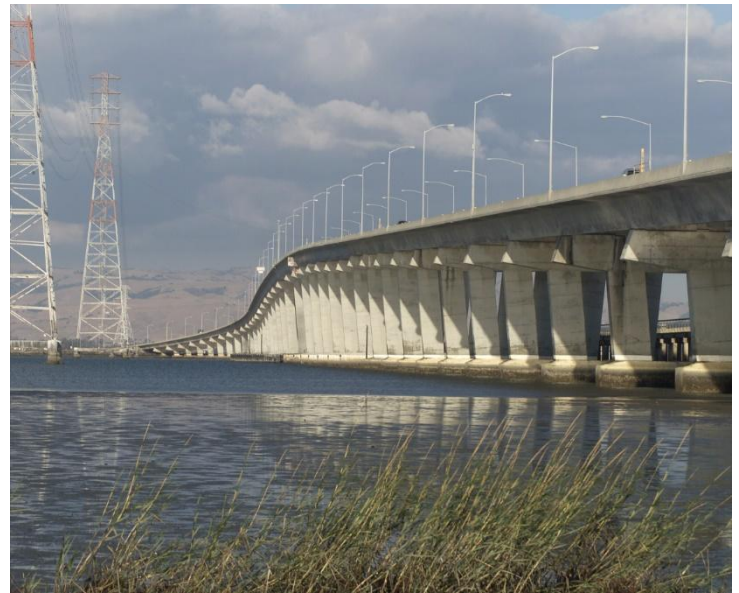
The Dumbarton Bridge carries State Route 84 for 1.6 miles between San Mateo and Alameda counties, with an eastern touchdown near Newark in Alameda County and a western landing near East Palo Alto in San Mateo County. The steel box girder main span and pre-stressed concrete approach spans were seismically retrofitted in 2013 to make the bridge safer during a major earthquake.

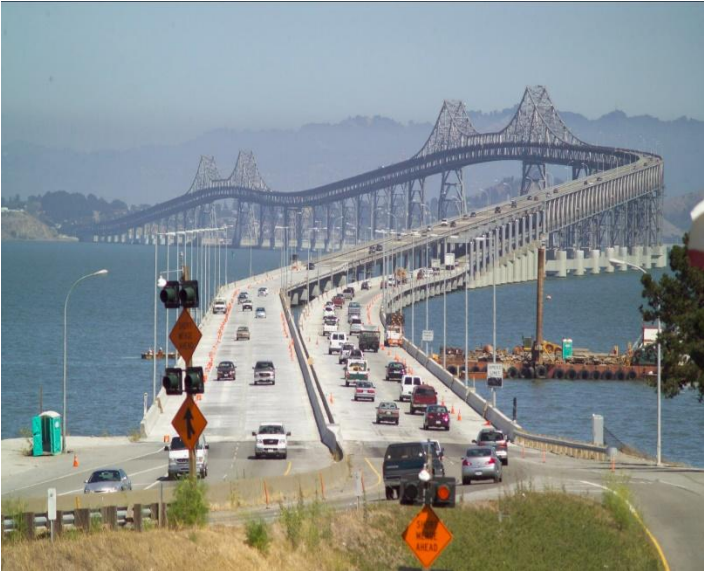
The Richmond-San Rafael Bridge has been a vital link for North Bay travelers for over 69 years. This 5.5 mile double-deck structure features two cantilever spans traversing two navigational channels.

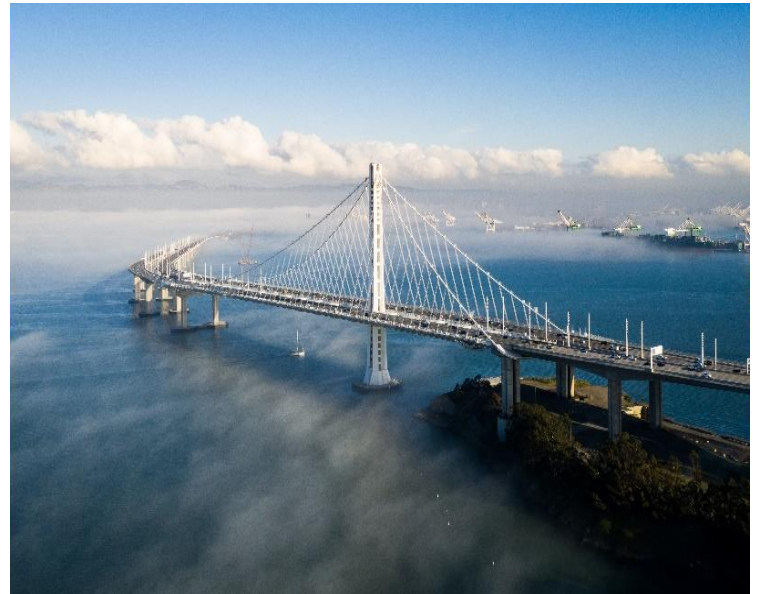
The San Francisco-Oakland Bay Bridge is the region's workhorse bridge, carrying more than a third of the total traffic on the Bay Area's seven state-owned toll bridges. The Bay Bridge's 89-year-old West Span is a jewel along the San Francisco waterfront. The new East Span, which opened in 2013, has become another Bay Area icon. The 2.2-mile East Span between Oakland and Yerba Buena Island includes a concrete skyway structure; a single-tower, self-anchored suspension bridge; and a transition structure that connects the side-by-side roadway decks with the double-deck tunnel through Yerba Buena Island. The 2.2-mile West Spans are adjoining double-deck steel suspension bridges with a center anchorage connecting Yerba Buena Island with downtown San Francisco. A seismic retrofit of the West Spans was completed in 2004.

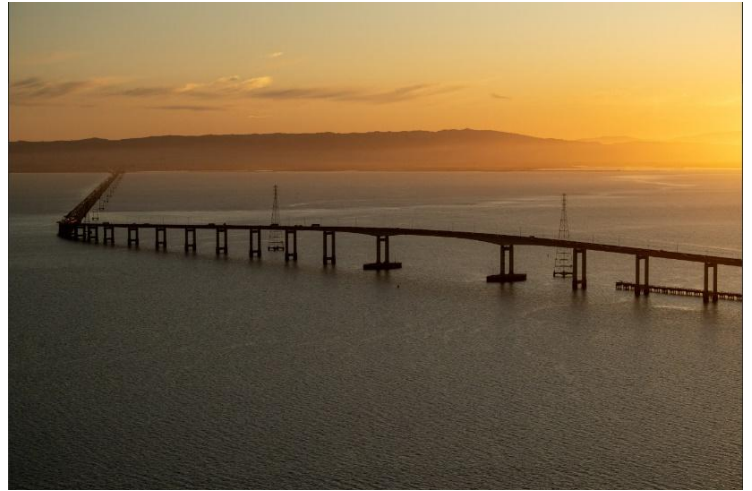
The San Mateo-Hayward Bridge carries State Route 92 between San Mateo and Alameda counties. The 1.9-mile high-rise section uses steel girder construction. The 5.1-mile low-rise portion of the bridge is made of parallel concrete trestle approach spans. Once one of the most congested evening commutes in the Bay Area, the San Mateo-Hayward Bridge saw enormous improvements in traffic flow with the completion of the 2003 concrete trestle for westbound traffic that allowed the conversion of the 1967 concrete trestle to eastbound only traffic. The seismic safety of the bridge was improved by Caltrans' 2000 completion of a retrofit project.

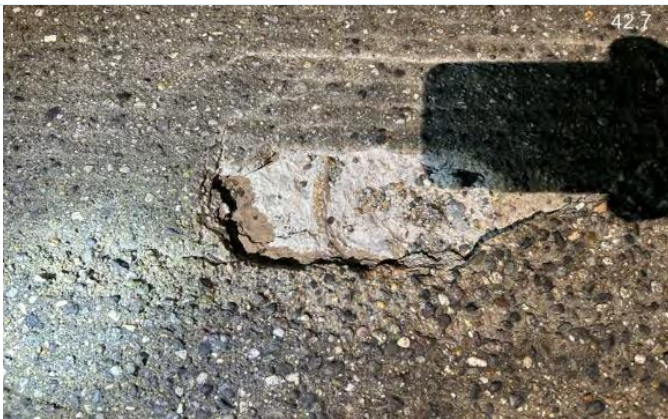
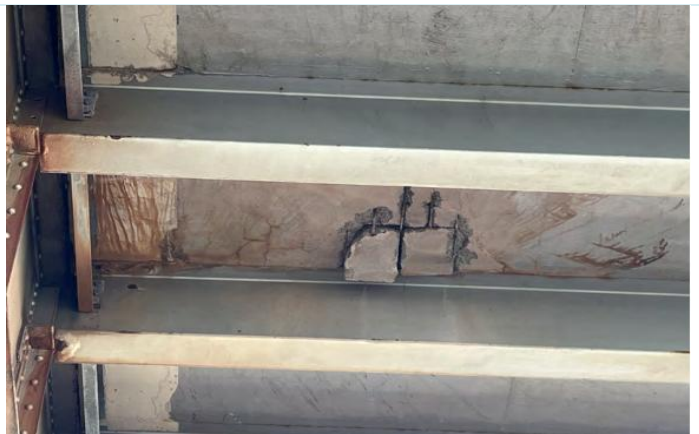
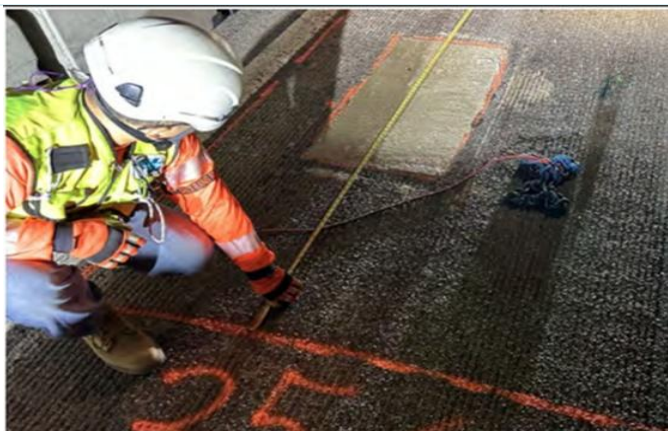
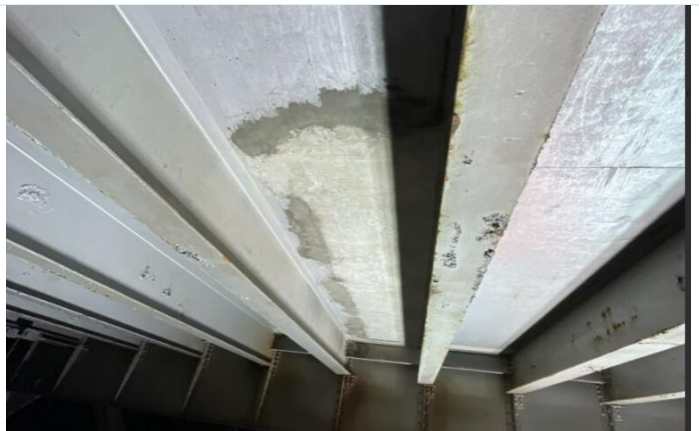
#### **Contract No. 04-4X030: Repair Bridge Deck Section**

This contract will remove cracked and unsound concrete, replace compromised reinforcement as necessary at various deck sections and replace it with polyester concrete.

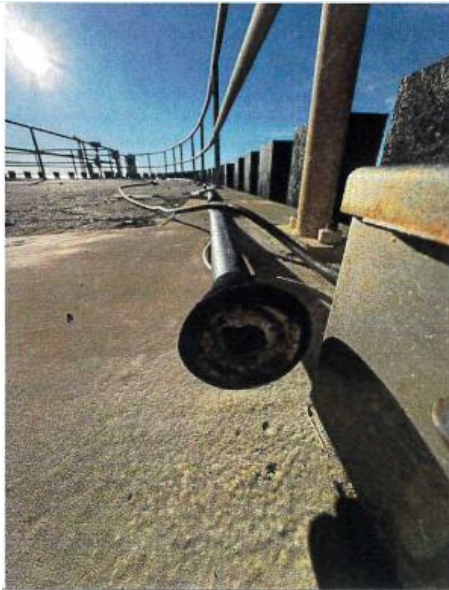
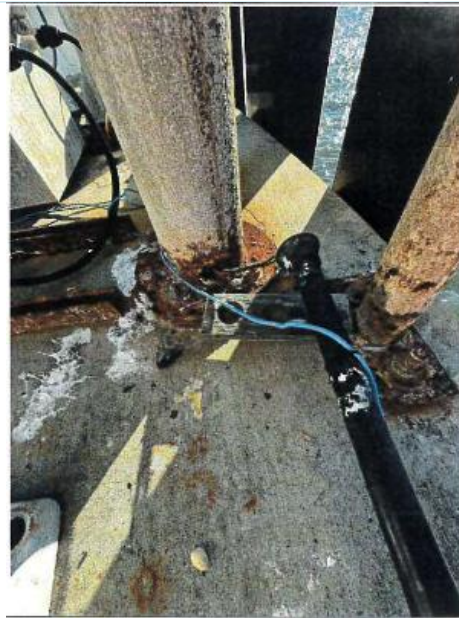
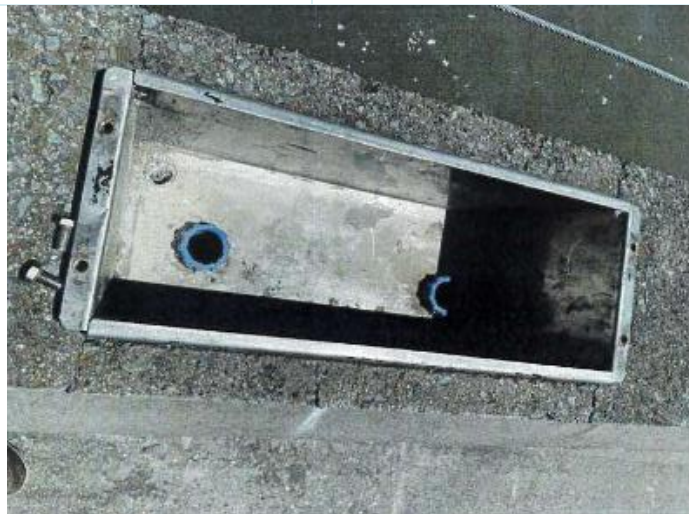
## Contract No. 04-3X150: Repair Communication Wire and Foghorn System

This project will restore the navigation and foghorn systems at Pier 48, which are currently inoperable due to damaged conduit and wiring. It will also involve the replacement of wiring that has been compromised as a result of theft and vandalism

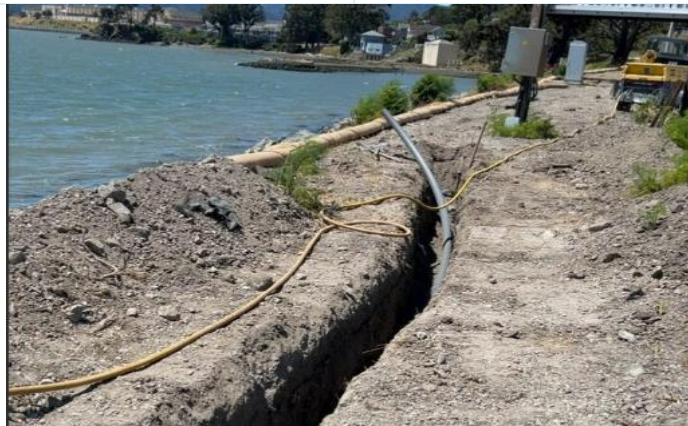
## Contract No. 04-3G364: Upgrade Electrical Substations and Power Cables

This project will upgrade the 4 existing electrical substations, upgrade the existing 5kV power supply to 12kV, and replace existing main communication cables feeding the substations.

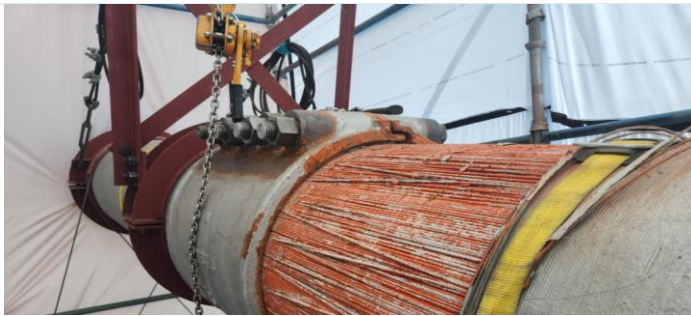
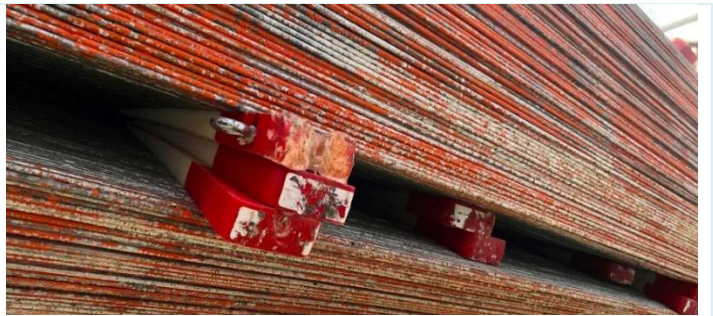
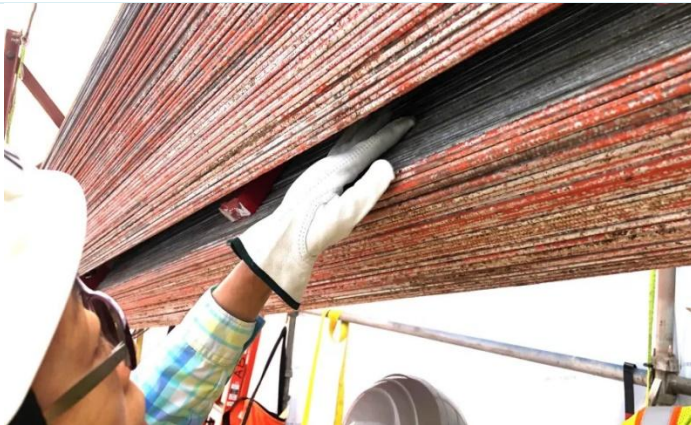
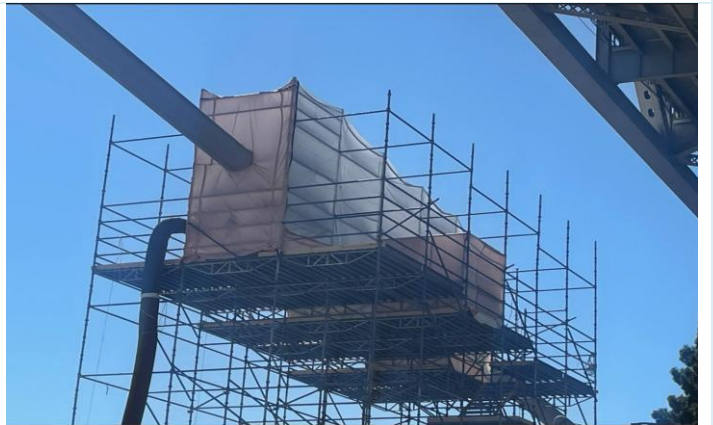
### **Contract No. 04-3G487: Structural Steel Paint and Miscellaneous Repairs**

This project involves cleaning and painting selected exterior and interior steel surfaces on both the lower and upper decks of the western span of the San Francisco-Oakland Bay Bridge (SFOBB). The scope includes work on a total of 331 panels across various spans. In addition to surface treatment, the project addresses a range of miscellaneous structural repairs such as replacement of rivets and bolts, restoration of navigational lighting systems and concrete repair in the upper deck soffit.

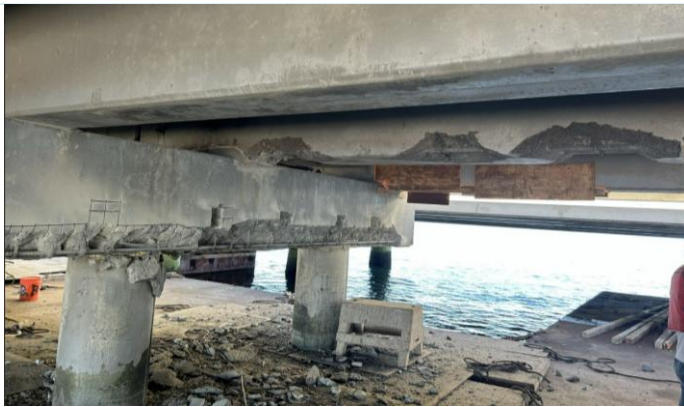
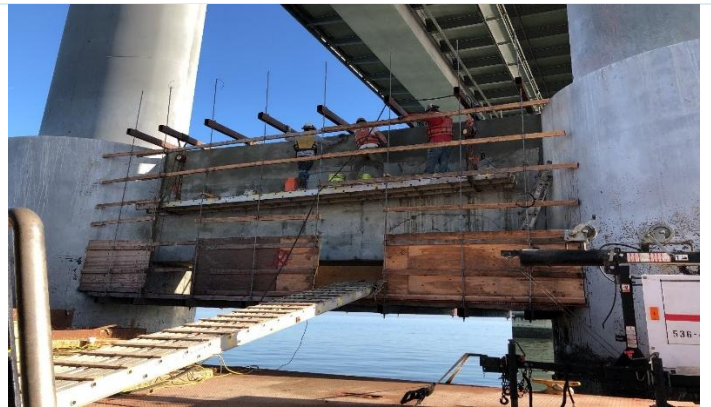
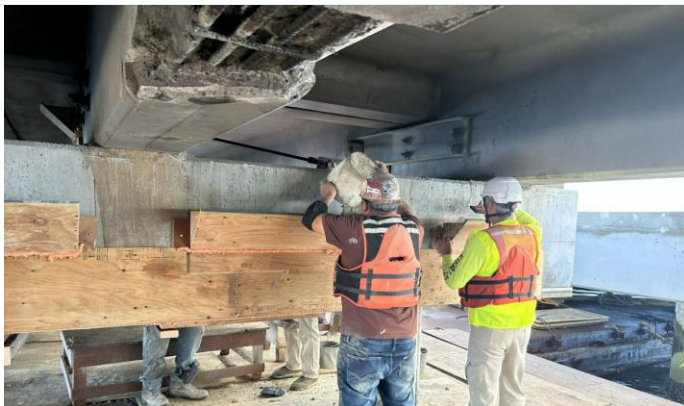
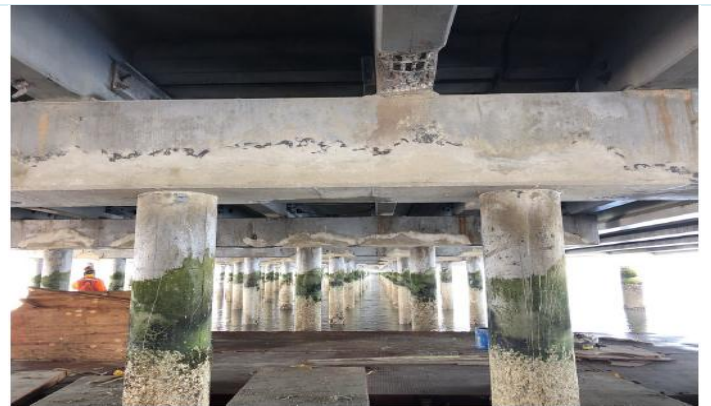
## Contract No. 04-3G4544: Spandrel Beam Reconstruction and Pier Cap Repair-Phase 1

Spandrel beam and pier cap structural repairs on the high-rise section of the bridge from Piers 12 to 29 (excluding piers 19 and 20), and pier cap and girder repairs on Trestle Section from Piers 286 to the east abutment.

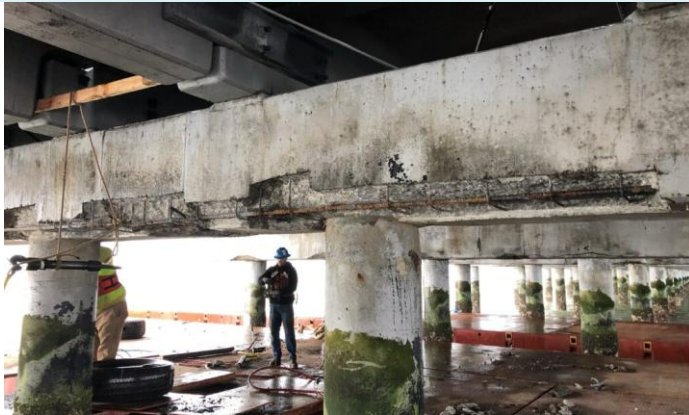
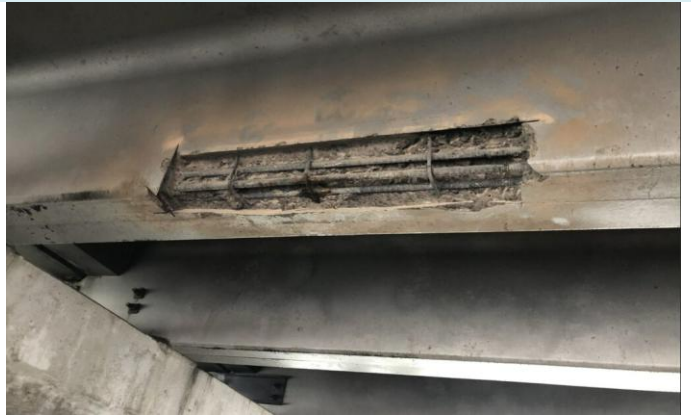
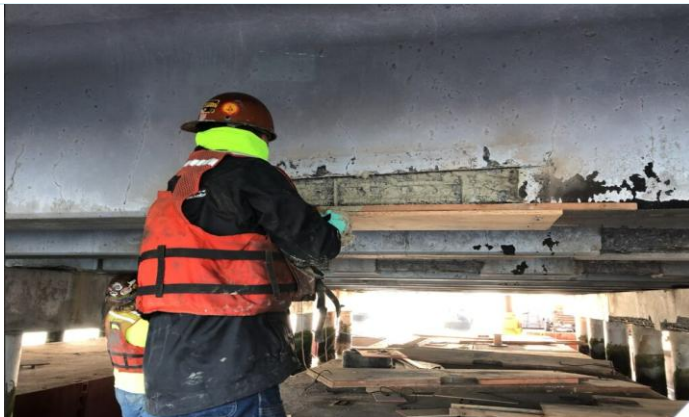
## Contract No. 04-1Y690: Spandrel Beam Reconstruction and Pier Cap Repair-Phase 2

This project is a continuation of 04-3G4544 project (Phase 1) to repair cracked and spalled concrete on the substructure of the San Mateo Hayward bridge.

\*Shown pictures are from phase 1
