Toll Bridge Program Report

April 2022

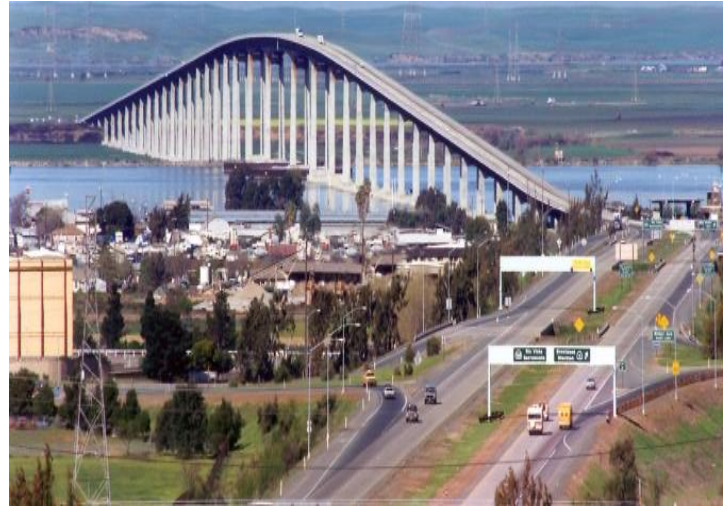
The structural components of the Antioch bridge are in good overall condition. The bridge deck is in fair to good condition with signs of wear to the concrete surface. The bridge substructure is in good condition, with deterioration limited to surface cracks. The bridge's superstructure, constructed of weathering steel, is in

similarly good condition. Several elements of the bridge superstructure were replaced and an additional substructure bracing was added as part of the 2013 seismic retrofitting contract. While BATA continues funding the ongoing routine maintenance work on the bridge, the bridge does not have major rehabilitation projects planned through 2022-2027.

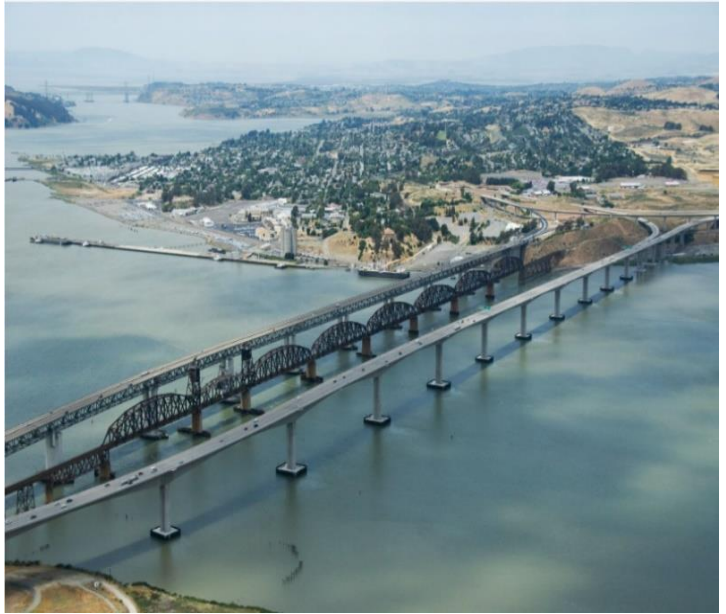
The structural components of both the northbound and southbound Benicia-Martinez Bridge structures generally are in fair to good condition. The bridge deck is in good condition with signs of spalling and delamination which are being monitored and repaired as part of the ongoing routine maintenance work. The bridge’s substructure is in overall good condition with some shrinkage cracks in the bridge towers.

While the superstructure of the northbound bridge is in good condition, the southbound superstructure is in fair condition, with the deck truss along the floor beams showing signs of deterioration which is being monitored. While BATA continues funding the ongoing routine maintenance work on the bridge, the bridge does not have major rehabilitation projects planned through 2022-2027.

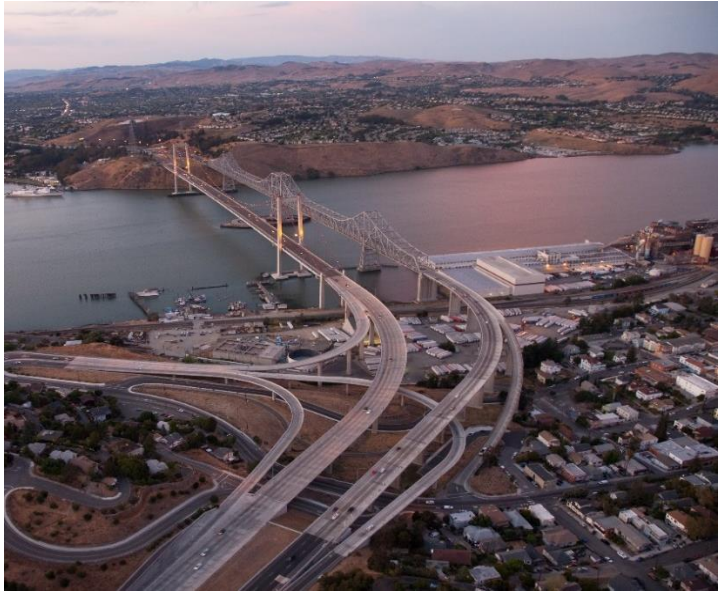
The structural components of the Carquinez Bridge generally are in fair to good condition. The eastbound bridge deck is in fair condition. A deck rehabilitation project to the eastbound approach structure (Contract 04-3G4034) was completed in 2016. The westbound bridge deck is in good condition, with signs of wear and rutting. While BATA continues funding the ongoing routine maintenance work on the bridge, the bridge does not have major rehabilitation projects planned through 2022-2027.

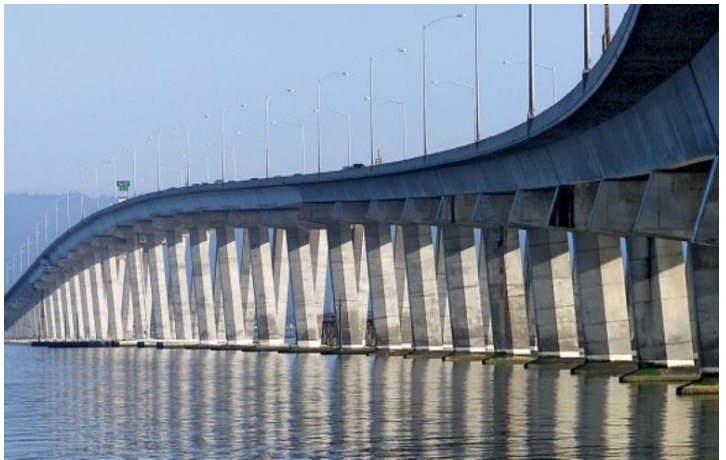
The structural components of the Dumbarton Bridge generally are in fair to good condition. The bridge deck is in good condition, with small cracks. The bridge’s substructure is in good condition, with minor shrinkage cracks in the concrete surface. The superstructure elements also are in good condition, with signs of deterioration.

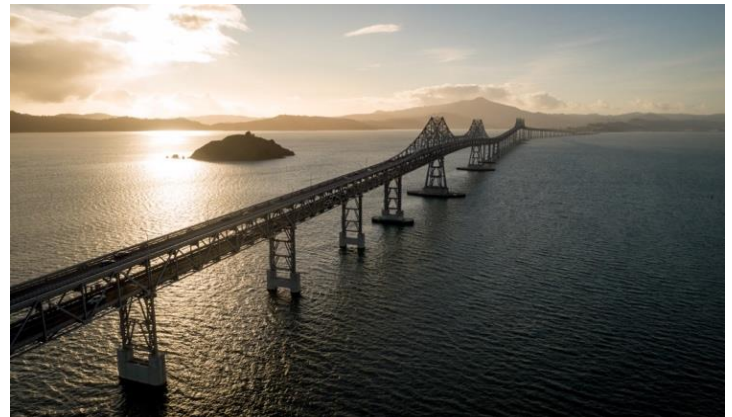
The structural components of the Richmond-San Rafael Bridge are in overall fair to good condition. The bridge deck is in good condition with signs of delamination and spalls in the surface. The bridge’s substructure is in fair condition, with signs of deterioration. The superstructure is in fair condition, with the steel truss spans and the steel girder spans showing signs of deterioration. A number of bridge deck joints were replaced as part of the structural steel paint project. According to the 10-Year Toll Bridge Rehabilitation Capital Funding program, over \$100 million will be invested between 2022 and 2027 to fund maintenance and rehabilitation projects on the Richmond-San Rafael Bridge.

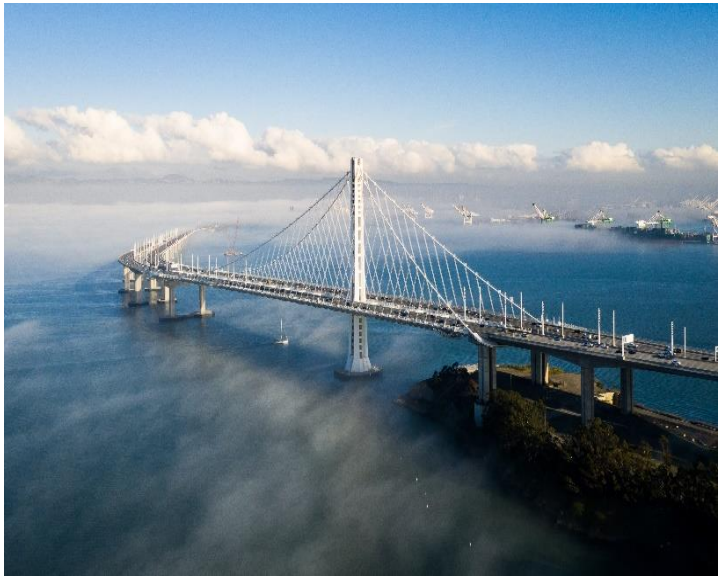
The East Span of the Bay Bridge is in good overall condition with slight signs of deterioration to its deck, structural components, and paint. No major rehabilitation projects are planned in the next 10 years. The older West Span, which is in fair condition, is the focal point for rehabilitation work. Current projects are dedicated to preventative maintenance. These include a major effort to paint the structural steel of the floor system and towers. As part of the 10-Year Toll Bridge Rehabilitation Capital Funding program, approximately \$400 million will be invested between 2022 and 2027 to fund maintenance and rehabilitation projects on the San Francisco-Oakland Bay Bridge.

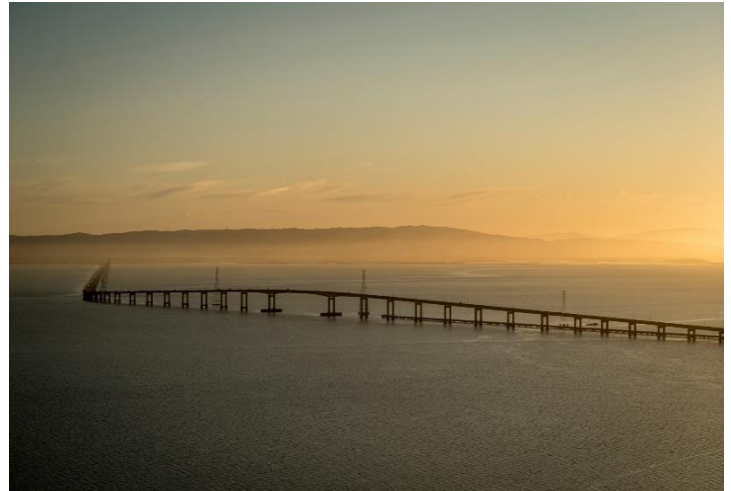
While the superstructure and deck of the San Mateo-Hayward Bridge are rated as good on the NBIS scale, Caltrans identified in 2016 spalling concrete on the pile caps of the older 1967 low-rise trestle section that resulted in a poor substructure and overall bridge condition rating. The spalling is due to the age of the structure, exposure to the bay environment and normal wear and tear. The poor rating does not mean the bridge is unsafe for the traveling public. The design of the trestle provides redundancy in the structural system, and the identified conditions do not indicate a safety risk which necessitates a closure.

A \$36 million Phase 1 rehabilitation of the bridge piers began in March 2020 and is on-going. The substructure component rating of the bridge is anticipated to rise to fair after completion of the work. In addition to the ongoing concrete repair work, additional toll bridge rehabilitation and paint projects are programmed in the Toll Bridge Rehabilitation Program. The total investment in the maintenance and rehabilitation of the San Mateo Hayward Bridge will be over \$100 million between 2022 and 2027.
