**Bay Area Toll Authority
Oversight Committee**

(i) Richmond-San Rafael (RSR) Bridge Pilot Project Recommendations

A status report and recommended next steps for BATA’s Interstate 580 (I-580) Richmond-San Rafael (RSR) Bridge Access Improvement Pilot Project (Pilot). Staff seeks:

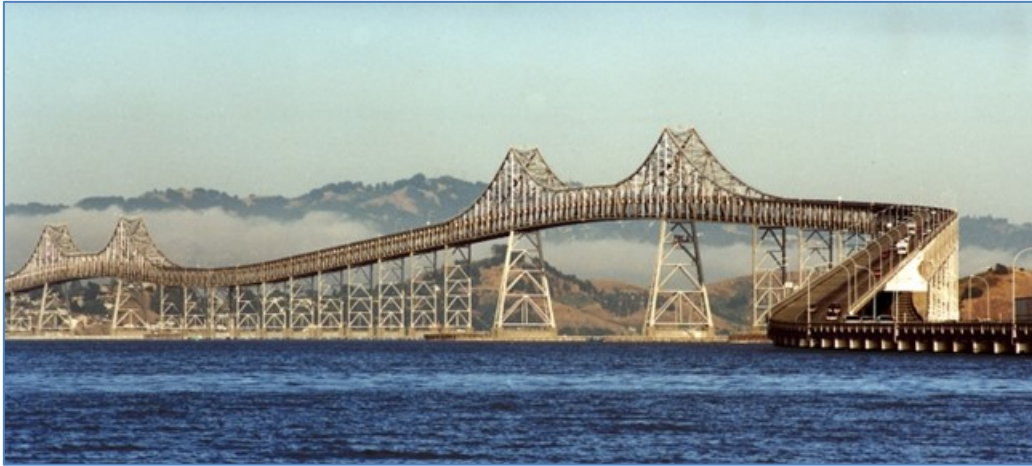
Figure 2-2: Richmond-San Rafael Bridge

Figure 2-2 provides a picture of the bridge. The bridge features two identical cantilever spans with a lower section in between. Both spans are 1,070 feet long, with a 185-foot clearance over water at the highest point. For much of its length, the structure has upper and lower decks rather than side-by-side decks. Westbound traffic is carried on the upper deck while eastbound traffic is carried on the lower deck. As a result of these features, the bridge has often been compared aesthetically to a roller coaster, a sea serpent, or a bent coat hanger.

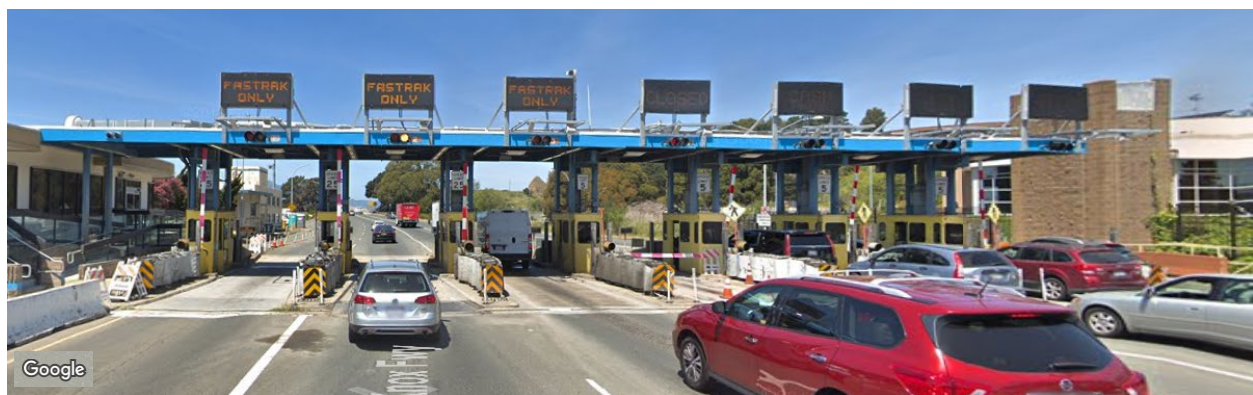
Figure 2-4: Approach to Richmond-Toll Plaza before March 2020

Like other east-west Bay Area bridges, a toll is currently assessed for vehicles crossing in the westbound direction, while no toll is charged in the reverse direction. The toll is collected at a plaza located in Richmond, approximately 500 feet from the foot of the bridge. Figure 2-3 provides an aerial view of the plaza, while Figure 2-4 provides a close-up view of the toll booths. On the approach to the toll plaza, the

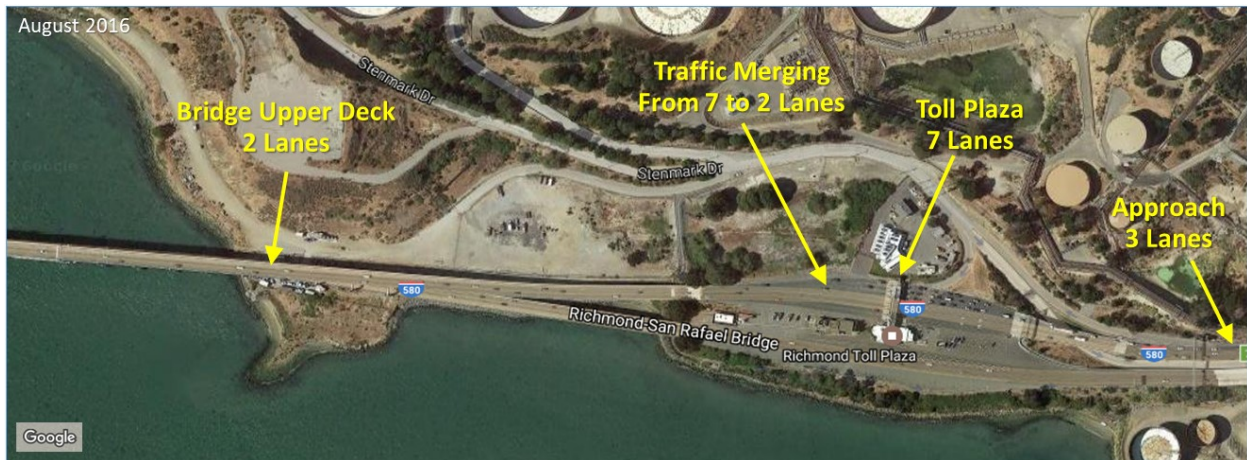
Figure 2-5: Initial Conditions – Westbound Bridge Approach in Richmond

Over time, increased volumes have led to increasing congestion on the westbound approach to the bridge. As indicated in Figure 2-5, the two main congestion-contributing factors were the toll collection activities and the fact that the bridge only carried two lanes of traffic while the freeway leading to it had three lanes. While it was often hypothesized that the toll collection activities were the primary cause of congestion, merging activities downstream of the plaza was the real culprit. Following a continuous

reduction in the number of vehicles paying the toll with cash, the expectation was that congestion upstream of the plaza would reduce. This is not what happened. By increasing the rate at which vehicles were able to go through the toll plaza, the adoption of electronically toll transponders by motorists resulted in more vehicles entering the merge area downstream of the plaza. This, in turn, caused increased frictions and slower speeds at the entrance of the bridge that propagated back through the toll booths.

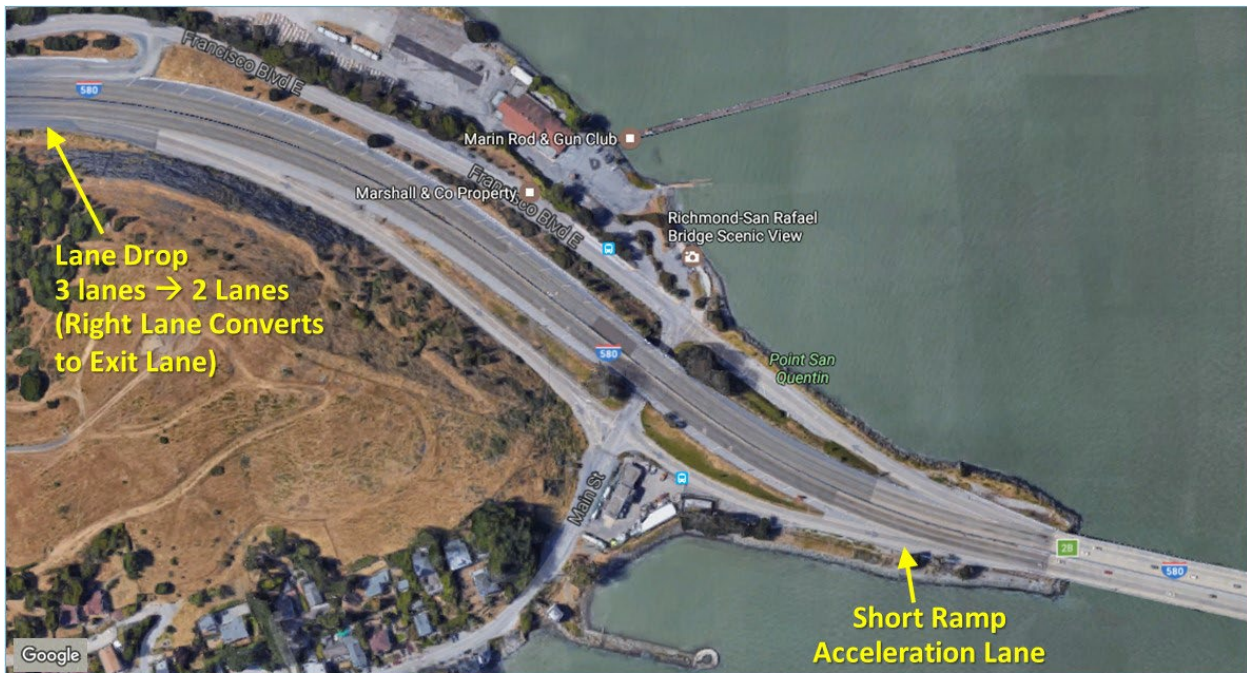
Figure 2-6: Initial Conditions – Eastbound Bridge Approach in Marin County

The eastbound approach in Marin County, shown in Figure 2-6, had also experienced a significant increase in congestion during the PM peak period due to increased traffic. In this case, the congestion was primarily caused by a reduction in the number of traffic lanes from three to two as the right-most lane converts to an exit lane approximately 2,000 feet from the foot of the bridge. Traffic merging from Main Street merging onto the freeway through a very short acceleration lane also contributed to the problem.

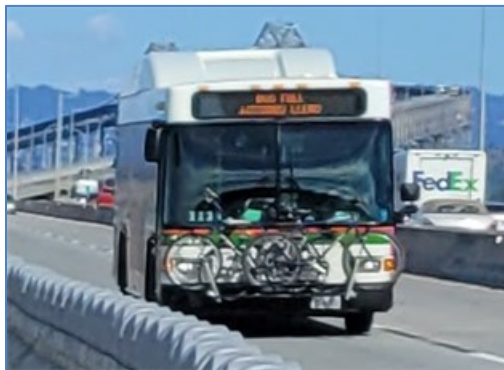
Figure 2-7: Golden Gate Bus Carrying Bikes on Front Rack

The only regular transit service across the bridge was, and is currently still, offered by Golden Gate Transit, a local transit agency serving servicing Marin and Sonoma counties, with limited service to San Francisco and Contra Costa County. To accommodate cycles, most Golden Gate Transit buses are equipped with exterior bike racks at the front of the bus or with underbelly bike racks, as shown in Figure 2-7.

- **Automated bicycle and pedestrian counts:** Data from automated counters installed on the multi-use path as part of the pilot project (available only for the after portion of the evaluation).
- **Bicycle Counts from Golden Gate Transit:** Information about the number of bicycles that were carried over the bridge by Golden Gate Transit buses on their front rack (see Figure 2-7).

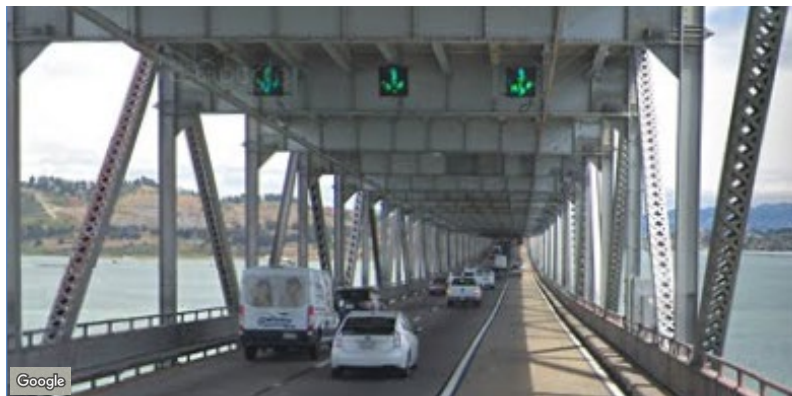
Figure 2-13: Electronic Lane Control Signs on Lower Deck

Figure 2-13 through Figure 2-19 present illustrations of the completed work. Figure 2-13 provides a Google Street View snapshot of the bridge lower deck with the installed overhead lane control signs, while Figure 2-14 provides a snapshot of the roadside sign explaining the lane control symbols used. Figure 2-15 presents snapshots of the electronic message signs that have been installed on the eastbound approach to indicate whether the shoulder lane is open or closed. Figure 2-16 further presents a snapshot of the upper deck of the bridge with the bikeway and moveable barrier, while Figure 2-17 presents a snapshot of the western end of the path along the Main Street off-ramp in Marin County. Figure 2-18 and Figure 2-19, finally, highlight aerial pictures of the various modifications that were made to the eastern and western approaches to the bridge.

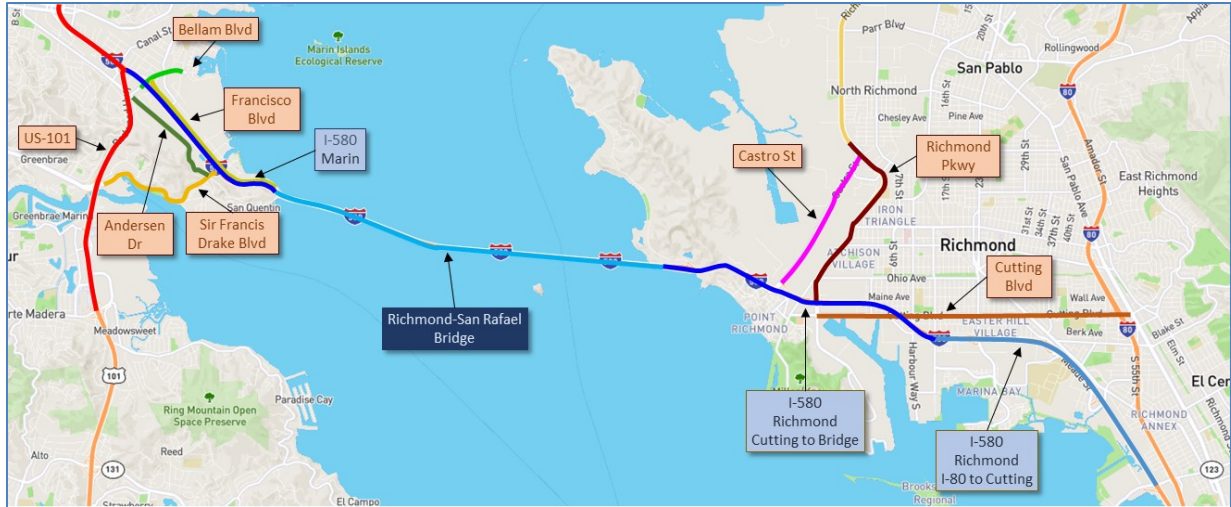
Figure 5-7: INRIX Travel Time Study Segments

Travel times along key freeway and arterial segments were obtained from the INRIX online data analysis platform through a login provided by the MTC. Specific segments for which travel times were collected are shown in Figure 5-7. This includes various segments along I-580, US-101, and key arterials within the study area.

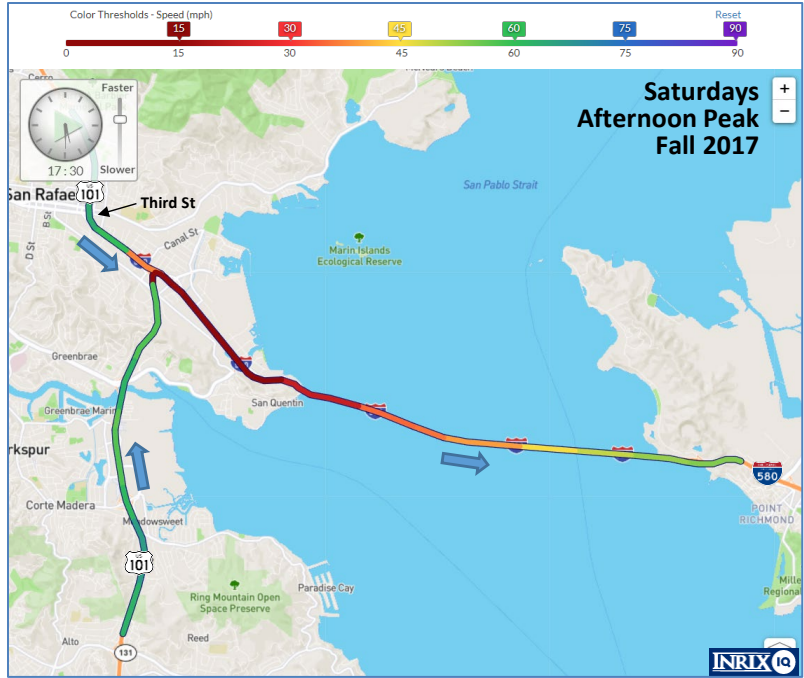
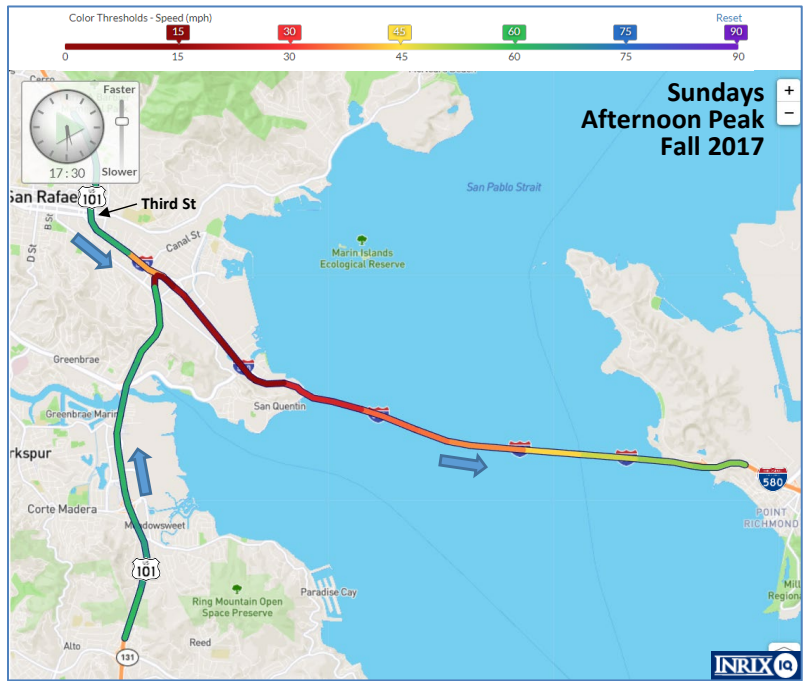
Figure 8-13 to Figure 8-15 illustrate the typical extent of the afternoon congestion before the shoulder lane opening on I-580 East in Marin County, the section of US-101 North south of the I-580 interchange, and the section of US-101 South north of the I-580 interchange. Data represents average observed speeds between mid-September and mid-November 2017, the last fall before the modification.

Figure 8-14: Extent of Congestion on I-580 East in Marin County before Bridge Modifications

Figure 8-15: Extent of Congestion on I-580 East in Marin County before Bridge Modifications

US-101 North between Sir Francis Drake Boulevard and the I-580 interchange also appeared affected. While part of the US-101 congestion could be attributed to the I-580 East congestion, another part could also be explained by traffic frictions between the I-580 and Third Street interchanges caused by the merging of the US-101 North and I-580 West traffic. Congestion on Saturdays and Sundays also typically extended up to the US-101 interchange but did not appear to affect traffic along US-101 North.

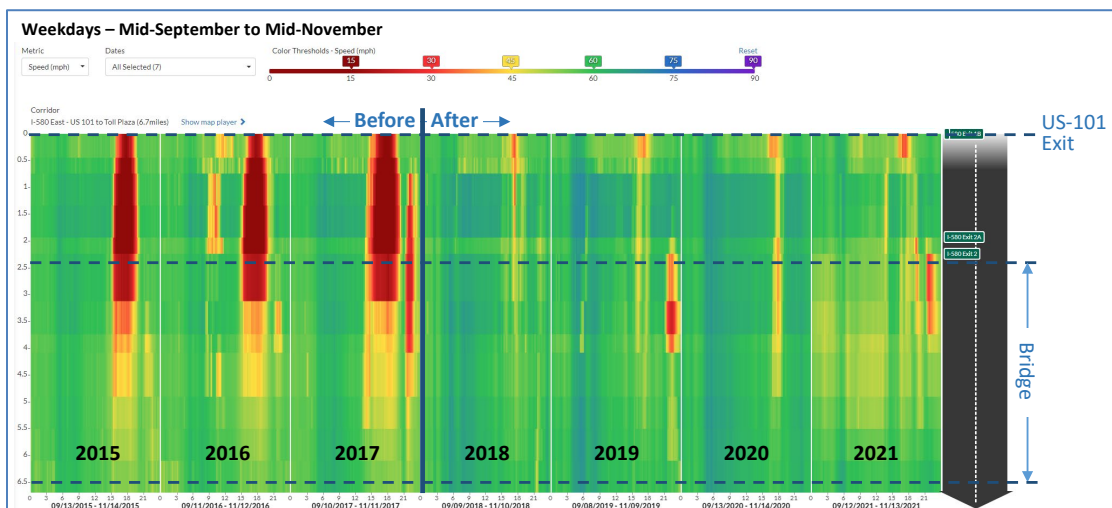
Figure 8-22: Speed Maps – I-580 East – US-101 to Toll Plaza – Weekdays, Fall 2015-2021

The opening of the eastbound shoulder lane to traffic during the afternoon peak has significantly reduced congestion on the Marin County approach to the bridge. This change can be observed in Figure 8-22 to Figure 8-24, which illustrates the average observed speeds on I-580 East from the US-101 interchange to the toll plaza on weekdays, Saturdays, and Sundays from mid-September to mid-November for each year between 2015 and 2021. Before the April 2018 modification, speeds typically dropped below 15 mph from approximately 3:00 to 7:30 PM from the US-101 to about 0.5 miles onto the bridge. After the opening, speeds have remained at or above 50 mph in the absence of disturbances from incidents or other bridge/roadway maintenance activities.

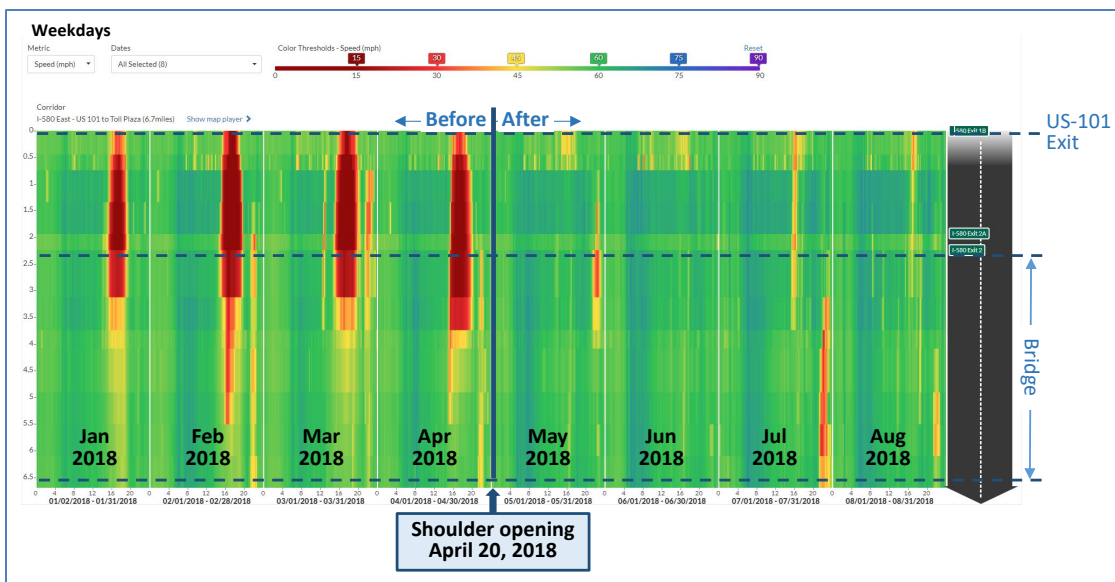
Figure 8-25: Speed Maps – I-580 East – US-101 to Toll Plaza – Weekdays, January-August 2018

While the 2020 data may be tainted with Covid-19 effects, this is not the case for the 2018 and 2019 data. The fact that the congestion on the approach disappears before the onset of the pandemic is proof that the improved conditions are a direct result of the bridge modifications. Figure 8-25 further enforces this point by illustrating observed speeds from four months before the modification to four months after. As can be observed, the change in traffic conditions unmistakably corresponds to the shoulder lane opening.

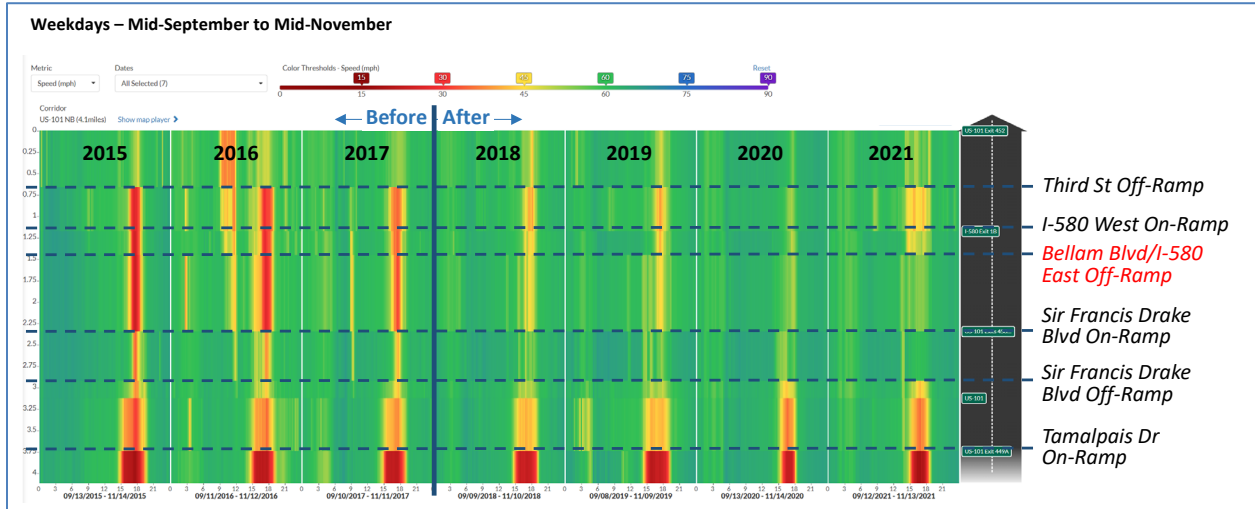
Figure 8-32: Speed Maps – US-101 North – Weekdays, Fall 2015-2021

Figure 8-32 compares the 2015 to 2021 mid-September to mid-November average speed profiles along the section of US-101 North extending from the Tamalpais interchange to the Third St interchange past the I-580 interchange. The thick vertical blue line indicates the boundary between observations made before the bridge modifications and observations made after. As can be observed, significant congestion existed on the US-101 North section between Sir Francis Drake Boulevard and I-580 before the modifications. As was noted in Section 8.2.1, this congestion could be attributed to both the I-580 East congestion and traffic frictions north of the interchange resulting from the merging of the US-101 North and I-580 West traffic streams. Following the bridge modifications, reduced congestion is observed on this section of US-101 in 2018 and 2019, before the Covid-19 pandemic, suggesting a direct potential impact from the bridge modifications. However, it can also be observed that congestion on US-101 North downstream of the off-ramp has also reduced.

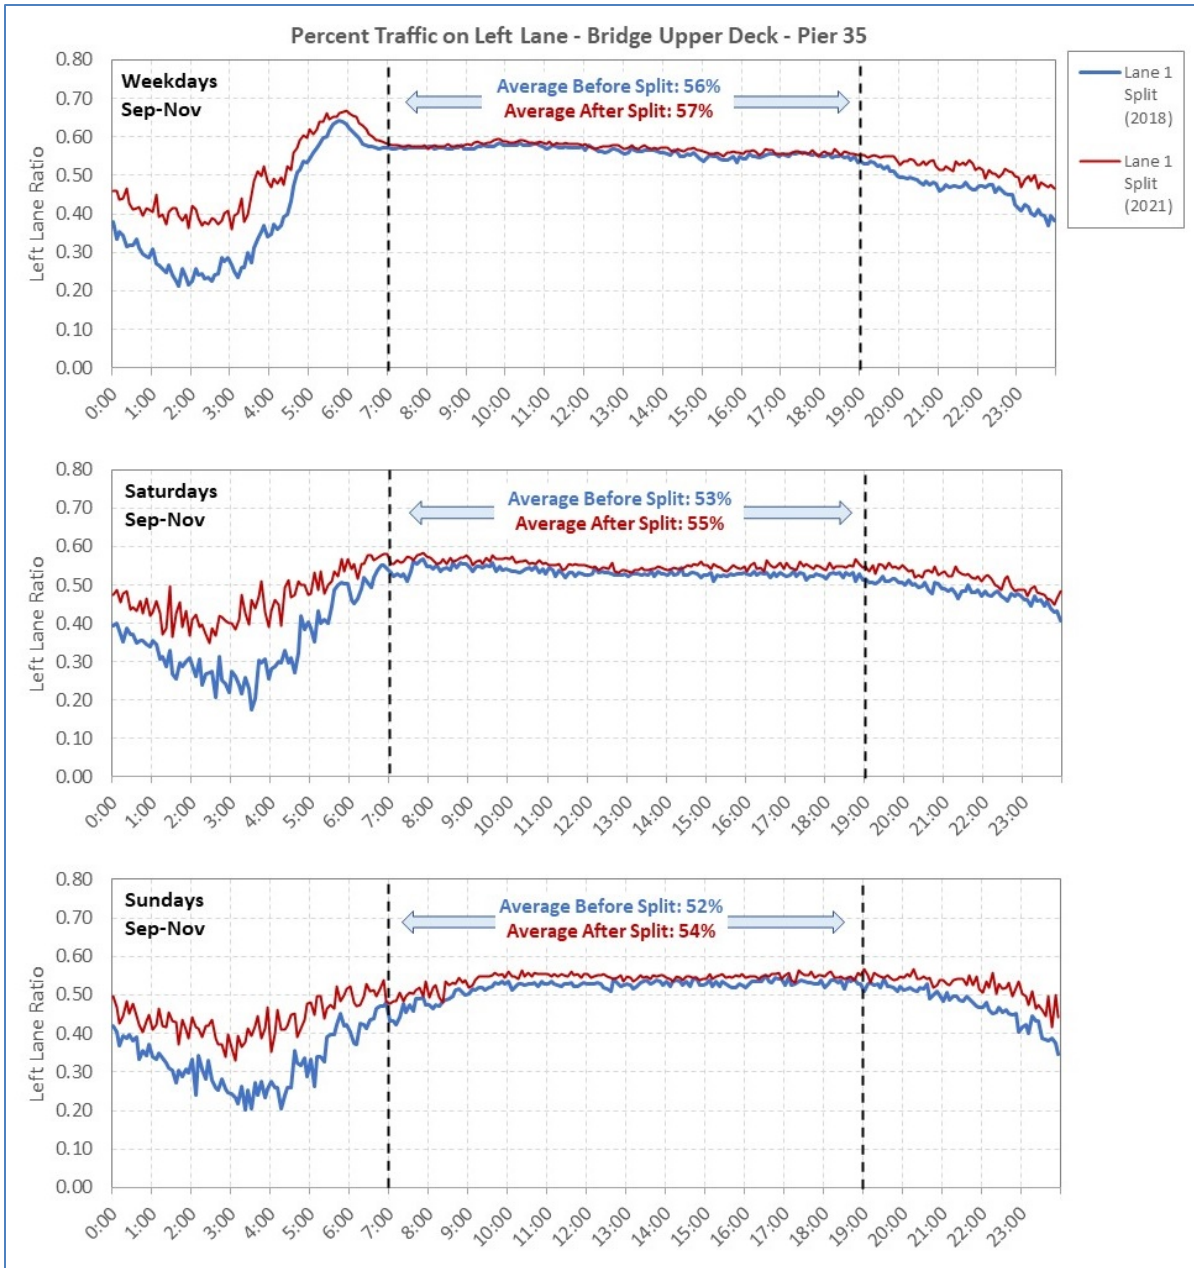
Figure 8-66: Percent of Traffic in Left Lane – Upper Deck, 2018 & 2021

- The closeness of the path's barrier to the right traffic lane appears to have caused 1-2% of peak-hour traffic to shift to the left lane, and up to 20% of the evening and night traffic to do the same. This has resulted in an average 57%/43% split across the left and right lanes during weekday peaks, and a 55%/45% split during weekend peaks.
