**Bay Area Toll Authority
Oversight Committee**

(i) Richmond-San Rafael (RSR) Bridge Pilot Project Recommendations

A status report and recommended next steps for BATA’s Interstate 580 (I-580) Richmond-San Rafael (RSR) Bridge Access Improvement Pilot Project (Pilot). Staff seeks:

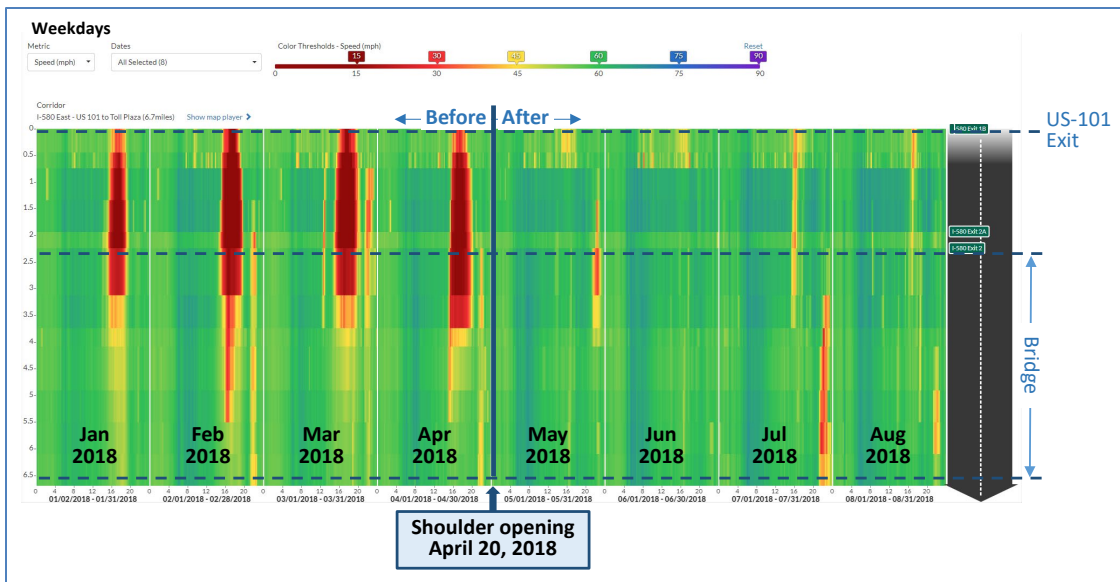
Figure 8-25: Speed Maps – I-580 East – US-101 to Toll Plaza – Weekdays, January-August 2018

While the 2020 data may be tainted with Covid-19 effects, this is not the case for the 2018 and 2019 data. The fact that the congestion on the approach disappears before the onset of the pandemic is proof that the improved conditions are a direct result of the bridge modifications. Figure 8-25 further enforces this point by illustrating observed speeds from four months before the modification to four months after. As can be observed, the change in traffic conditions unmistakably corresponds to the shoulder lane opening.
